## Phase II 2009 Garcia River Sediment Source Assessment

Garcia River Forest,  
Mendocino County, California

PWA Report No. 10073507  
April 2010

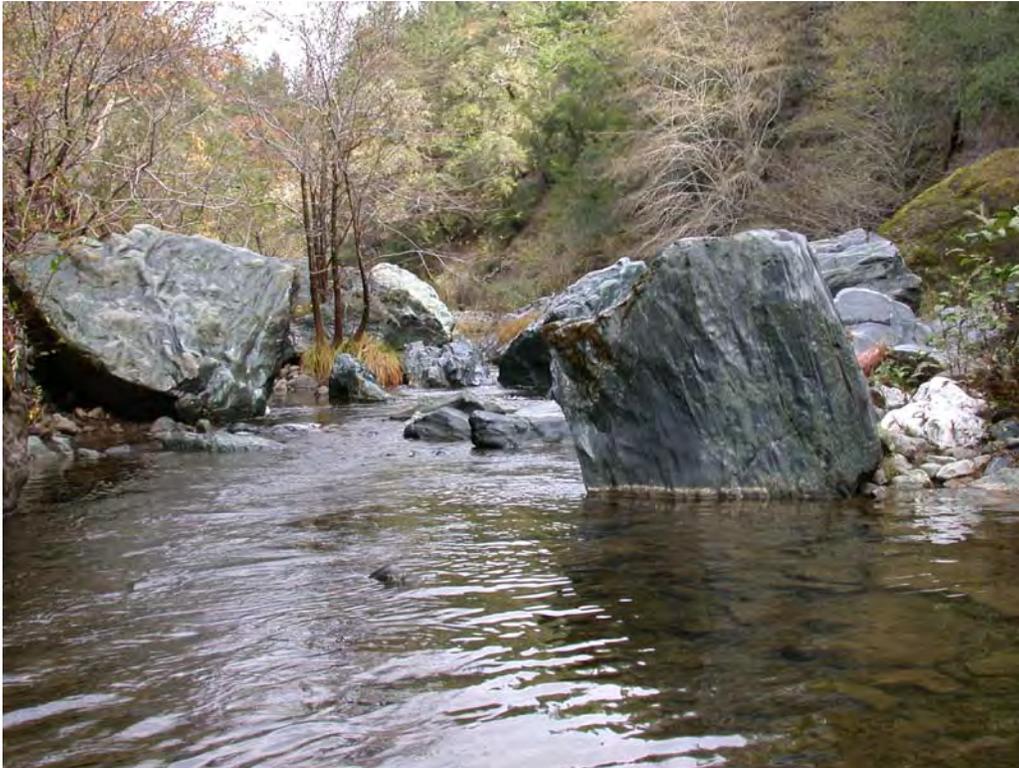
The surveyed reach has very high quality boulder pocket water and bedrock trench pool habitat. (Figure 1-3). Some of the largest and deepest pools in the upper Garcia River are located in this reach. (Figure 2) and these pools should be considered as very important holding water for up and downstream migrating adult salmonids especially during low flow condition between storm events. Adult salmonids holding in these pools are vulnerable to poaching, and should be monitored for this illegal activity during the winter months. There has been poaching in the past at these sites (CDFG Warden Ed Ramos personal communication). Currently, juvenile salmonid rearing in this reach of the main stem Garcia River is limited by high water temperatures (Figure 4). These deep pools should be temperature monitored to discover whether they are stratifying (cool water at depths). If suitable temperatures exist, these pools may be serving as thermal refugia for coho salmon juveniles at present. A dive survey in early August to monitor for juvenile salmonid presence is also recommended.

**Figure 1: Boulder pocket water along the mainstem Garcia River that would be good rearing habitat, if temperatures were suitable.**

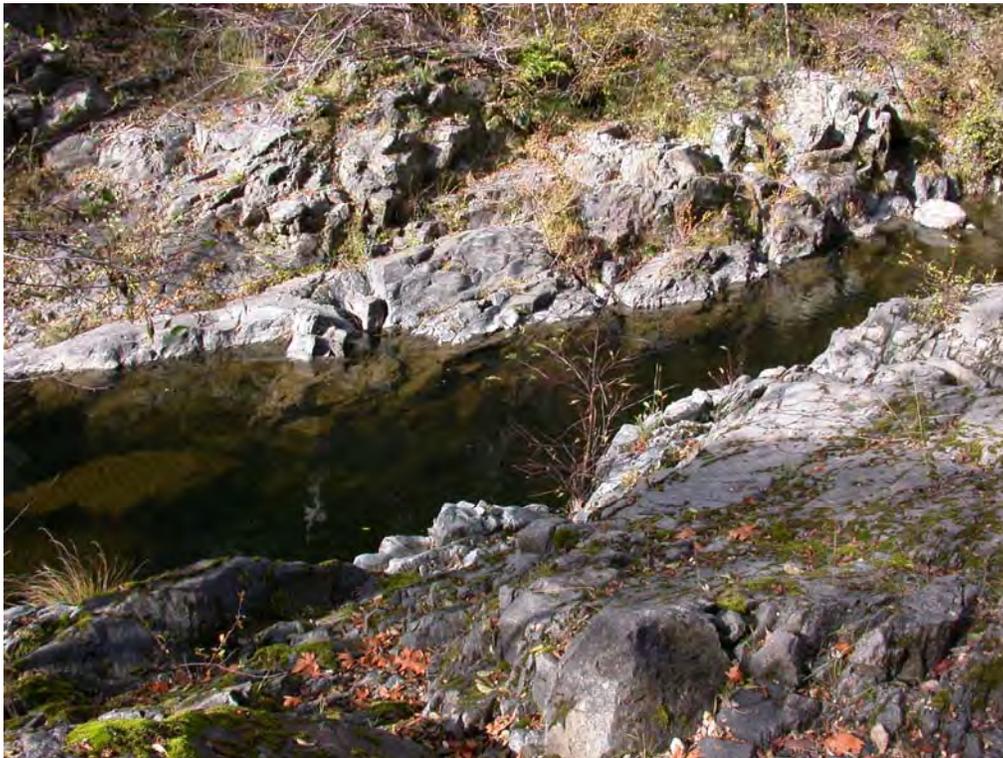
**Figure 2: Garcia River mainstem deep, bedrock trench pool suitable for holding migrating adult salmon and steelhead.**

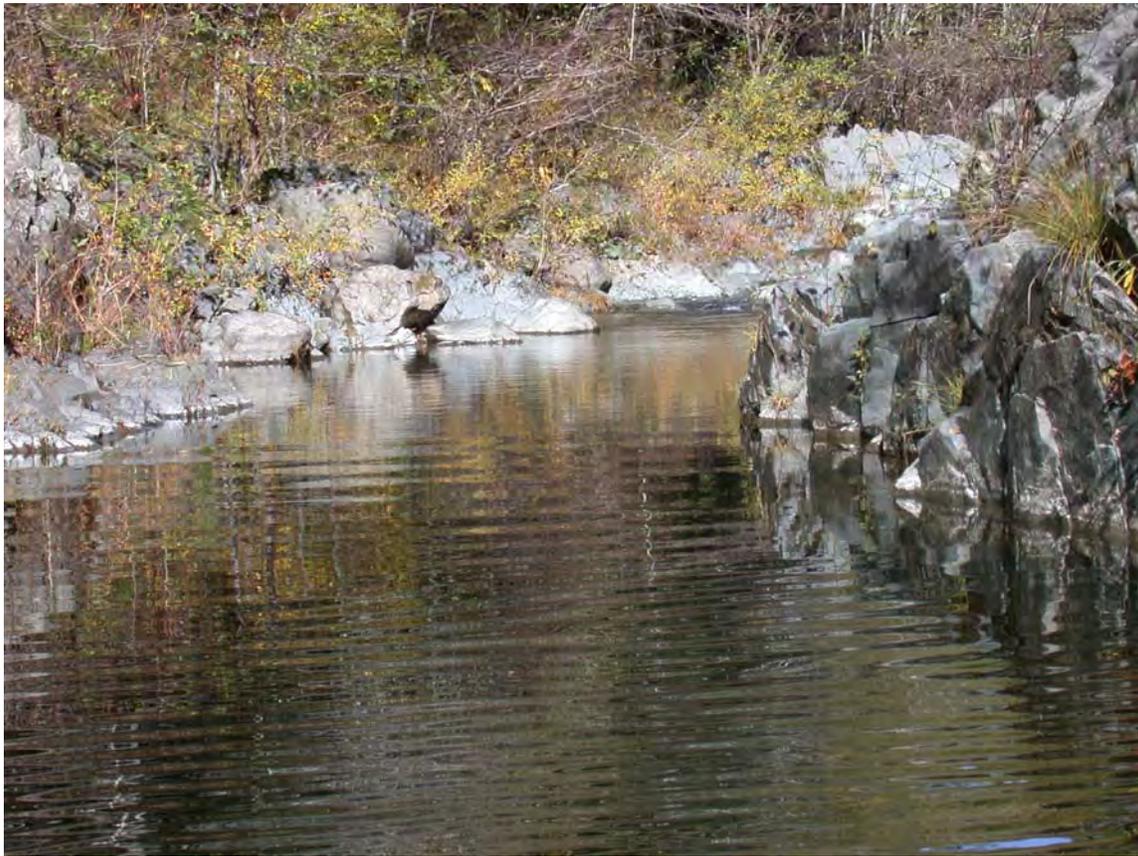
Figure 3: Close up of bedrock trench pool greater than 10 feet.

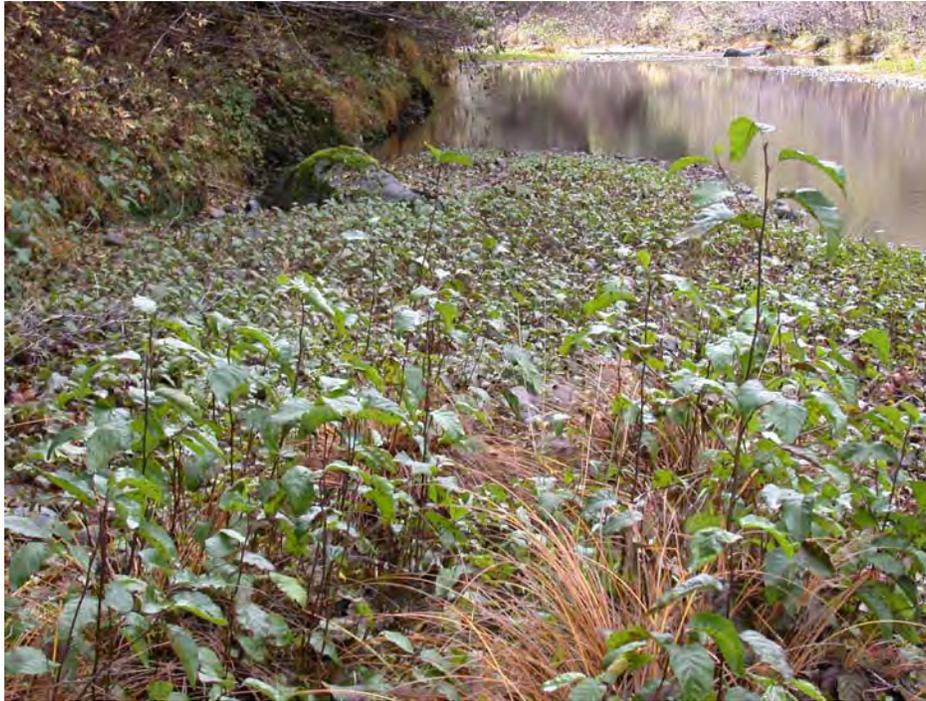
**Figure 5. Natural recruitment of alder along a mainstem Garcia River terrace is shown during November 2008 surveys is a positive sign for succession as these will trap soil, build banks and ultimately a more confined and deeper mainstem.**

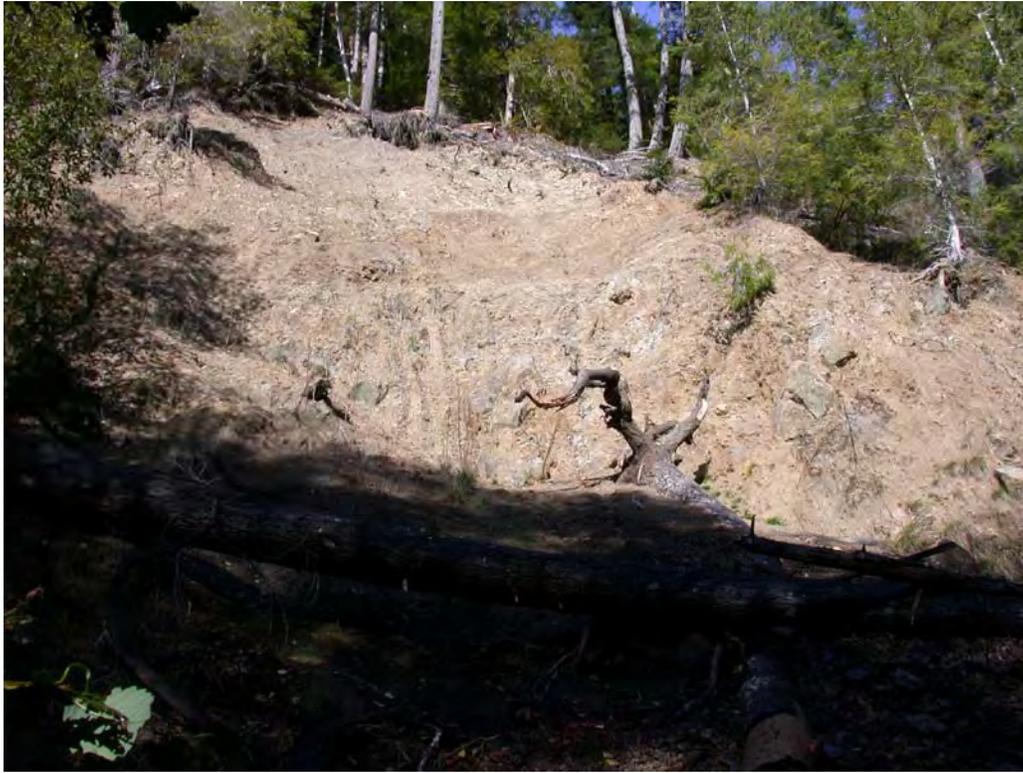
**Figure 6. Debris slide on North Fork Garcia is not a site for riparian restoration (Site 15a).**

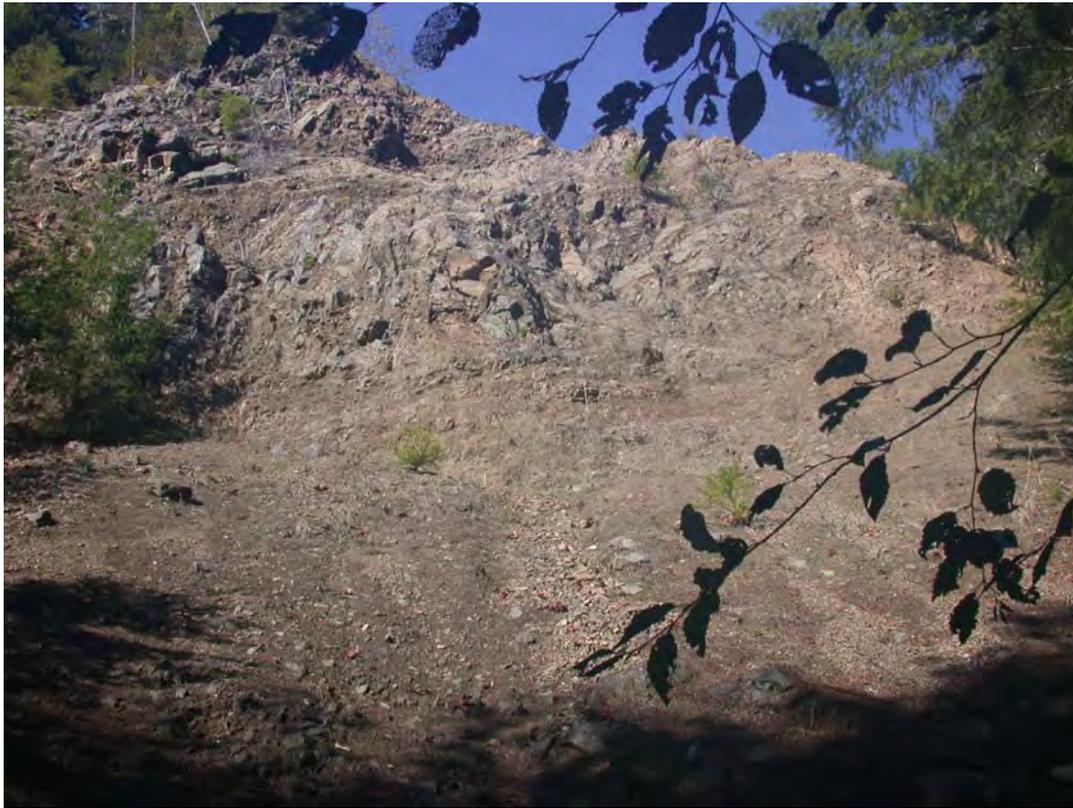
**Figure 7. Debris slide on North Fork Garcia may actually be a site of spawning gravel recruitment, which is important because spawning gravels may be limiting (Site 15b).**

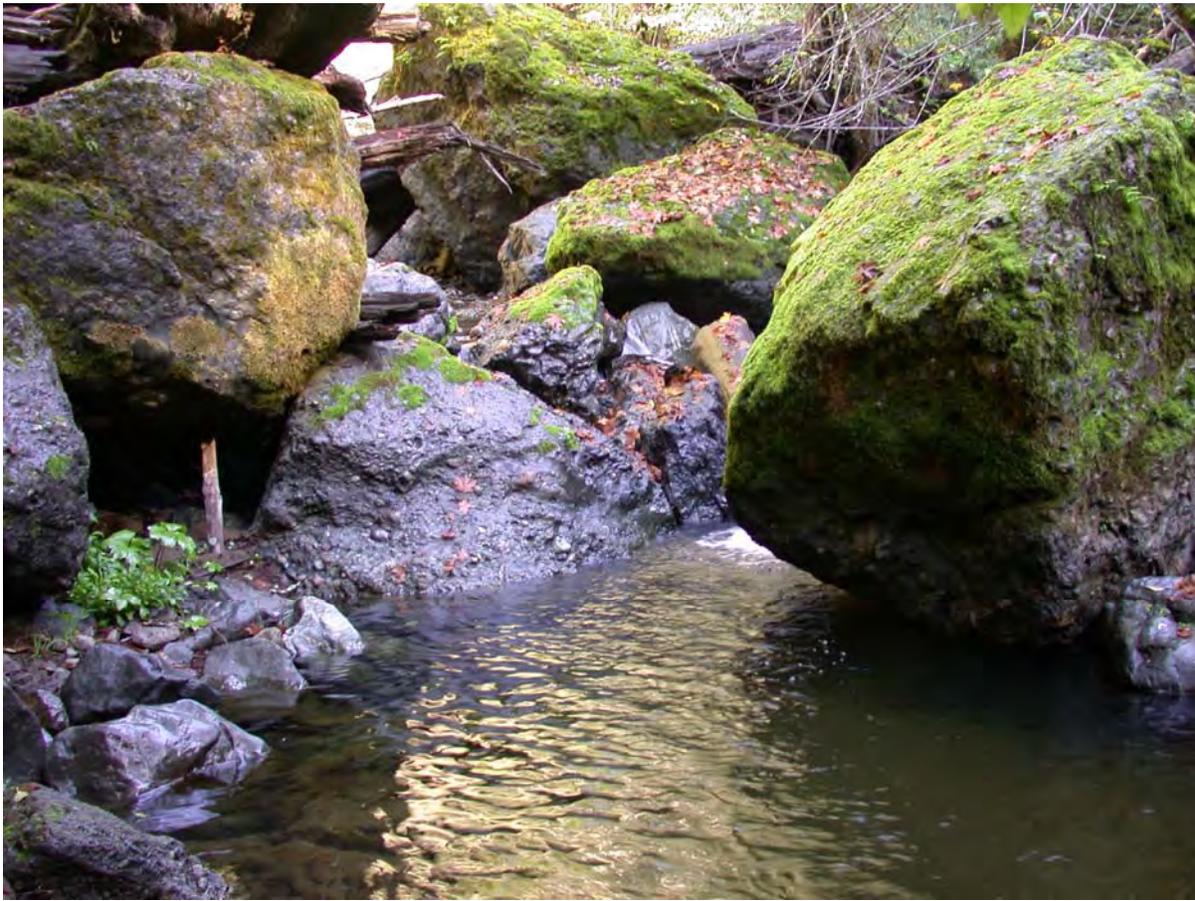
**Figure 8. North Fork Garcia upper extent of steelhead access due to complete migration barrier formed by boulder jumble and LWD. May be preventing spawning gravel recruitment below.**

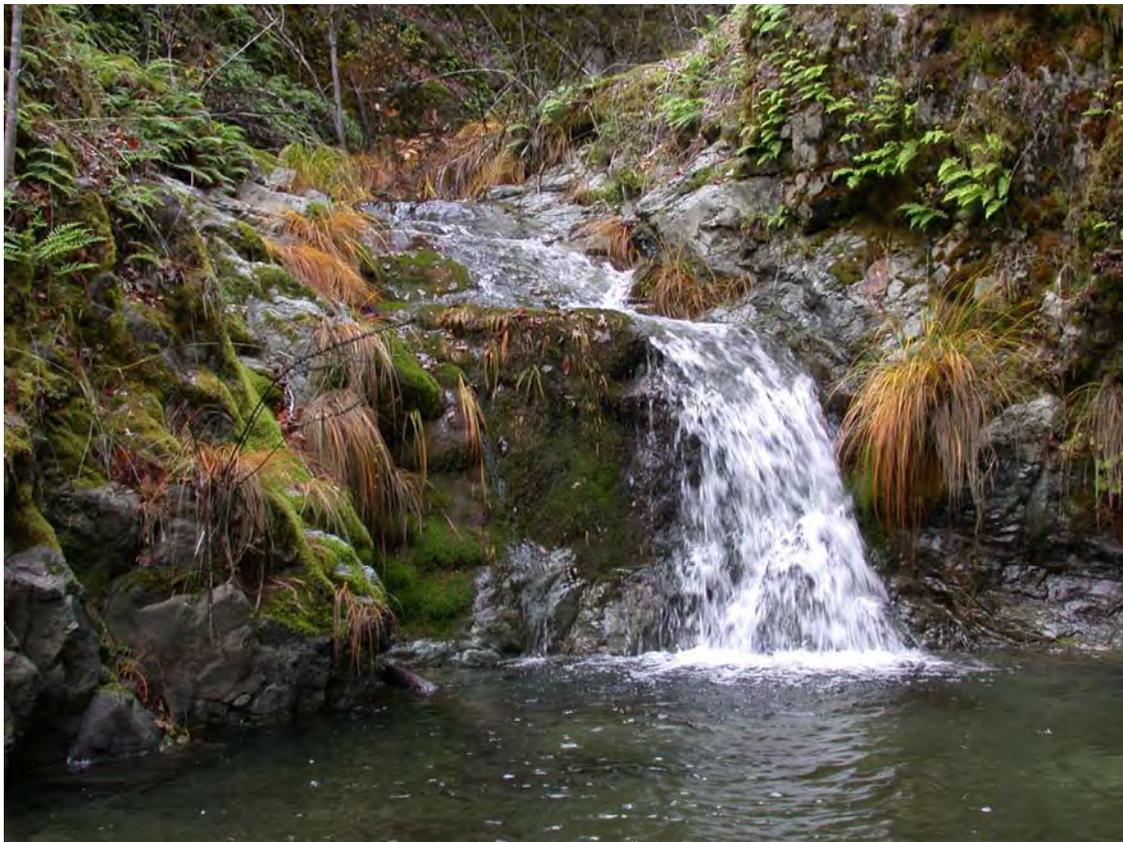
**Figure 9. Ten foot high waterfall is the upper limit of steelhead access in Graphite Creek.**

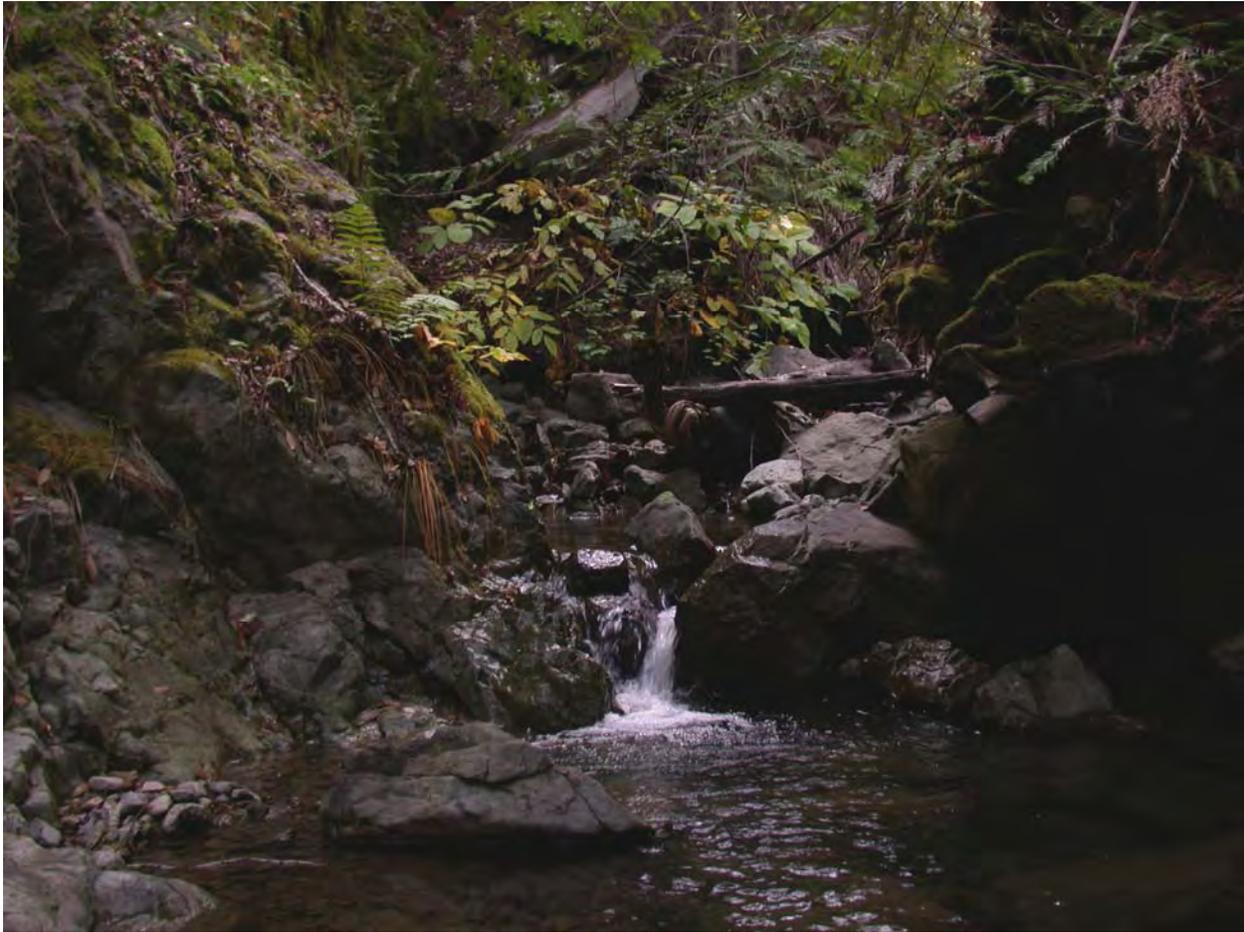
**Figure 10. Potential barrier #3 on Graphite Creek.**

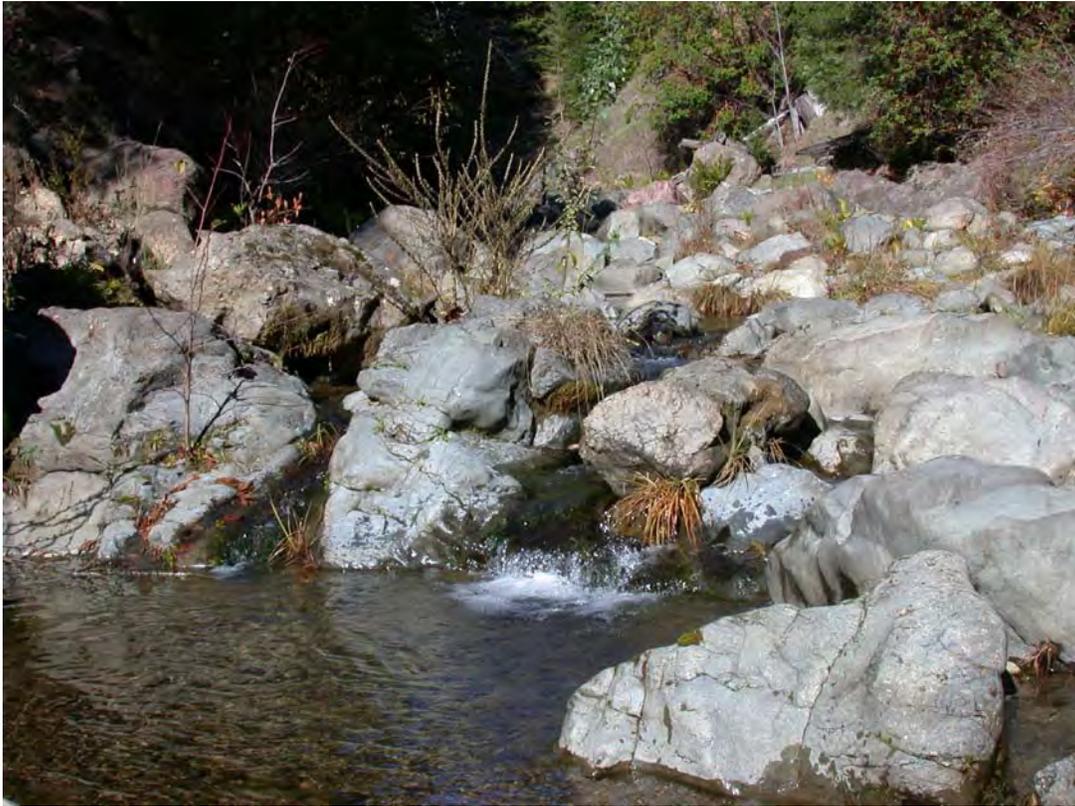
**Figure 11. Lower Blue Waterhole Creek, moderate/high gradient boulder, riffle habitat but summer water temperatures exceed 25 C during summer that likely makes it sometimes unviable as salmonid rearing habitat.**

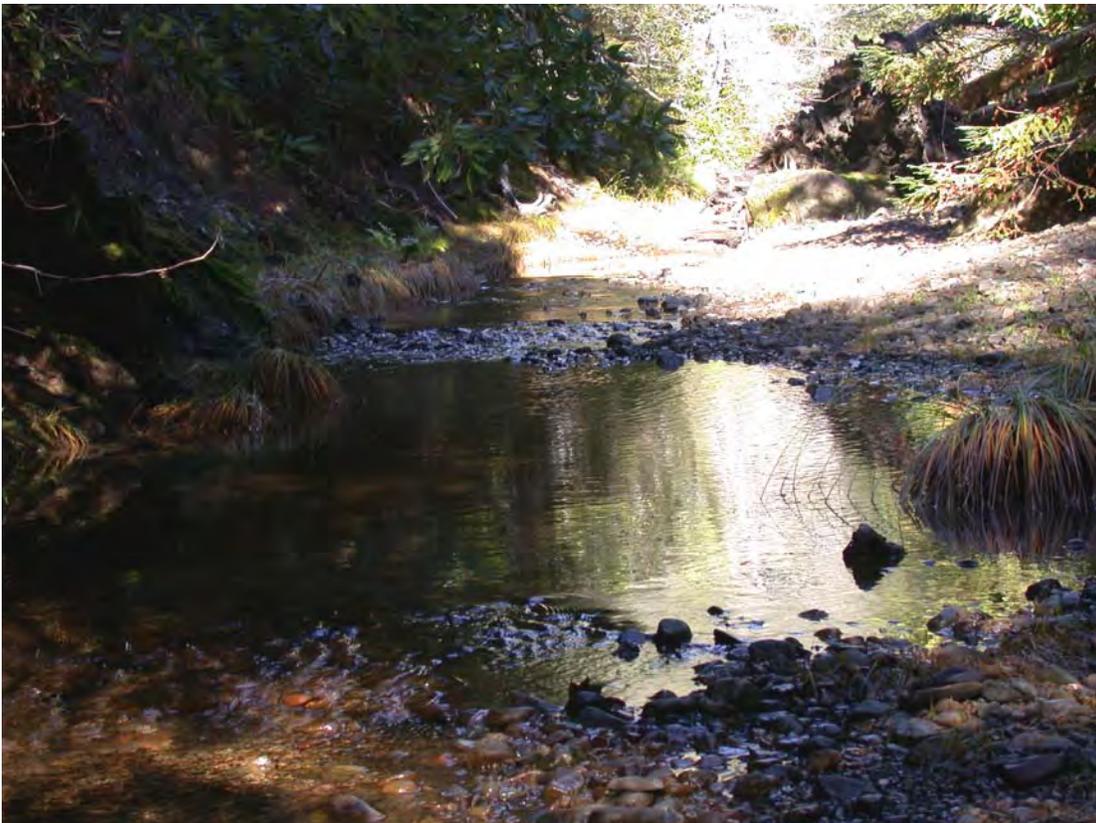
**Figure 12. Low gradient reach of Blue Waterhole suitable for steelhead spawning and rearing.**

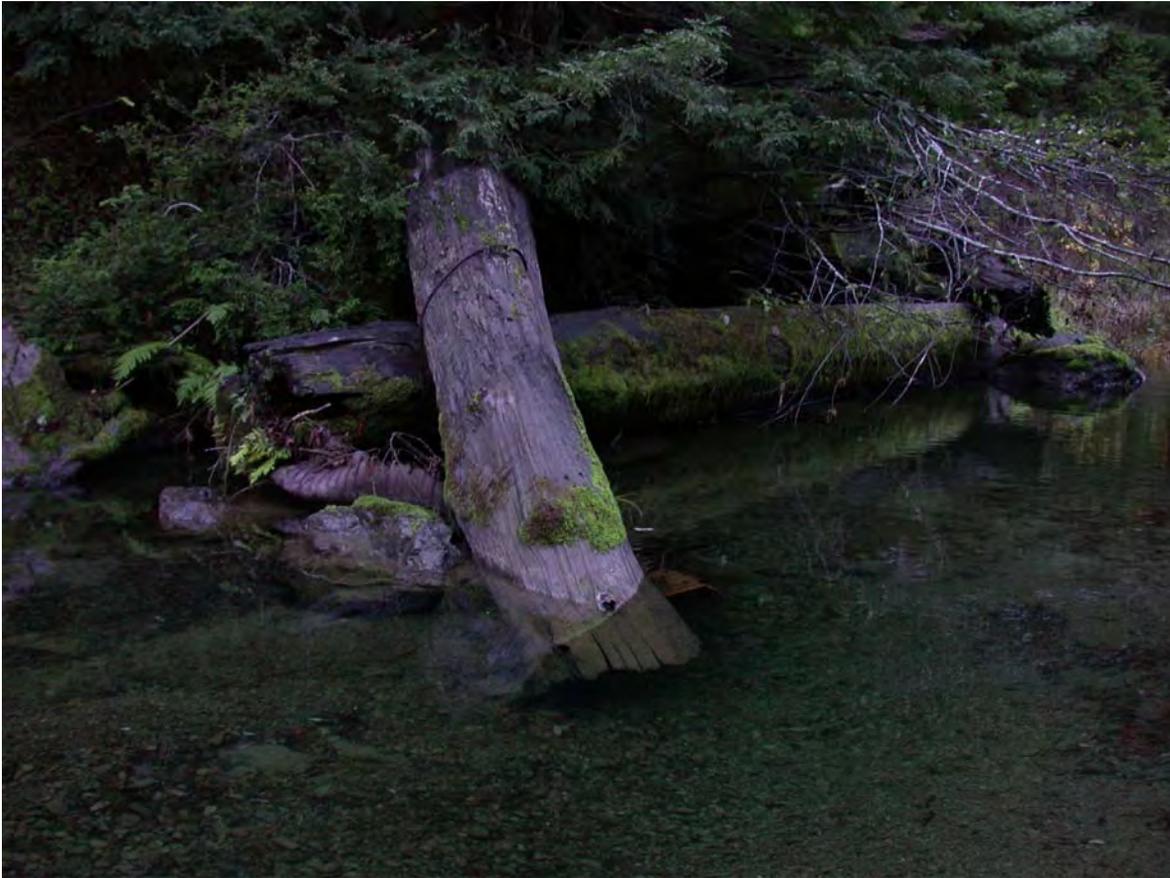
**Figure 14. Instream structure on Blue Waterhole Creel built by New Growth Forestry in 1980's. Note crumpled culvert intertwined within structure likely from upstream crossing failure.**

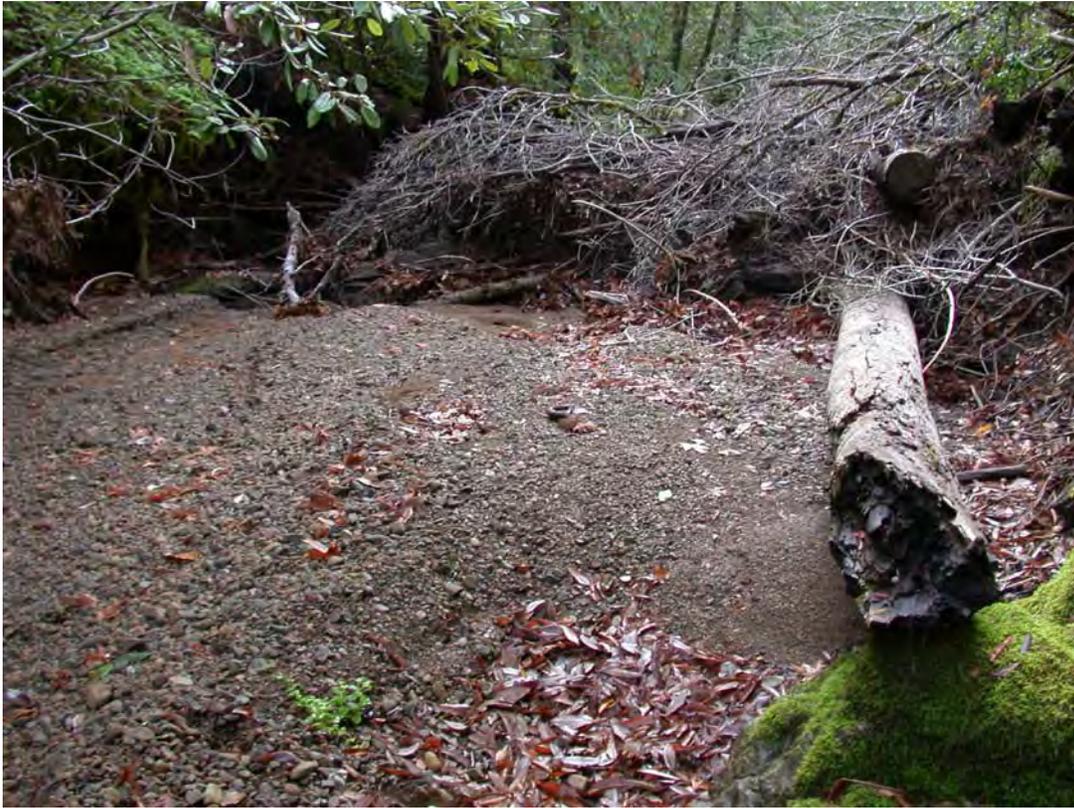
- Some reaches surveyed were underground, likely due to aggradation.
- The upstream barrier to migration is a spanning LWD jam and sediment deposited upstream of it suggests that the stream is currently oversupplied (Figure 15). This location coincides with the upstream boundary of the Garcia River Forest property.
- Upstream sources of sediment need investigation and erosion prevention and control measures implemented.
- Recommend that upper barrier be considered for modification after excavating sediment.

**Figure 15. Spanning logjam at upstream barrier to steelhead on Whitlow Creek at Garcia River Forest property boundary. Sediment trapped above the LWD suggests sediment over-supply from some unknown upstream sources in the watershed.**
