**Final Report:  
The Conservation Fund  
Garcia River Forest Phase 1 Assessment  
Mendocino County, California**

PWA Report #08068303  
March, 2008

**CDFG Fisheries Restoration Grant Program  
Salmon and Steelhead Trout Restoration Account  
Contract #P0430414**

**Long term road drainage and  
erosion control plan for the  
Inman Creek and Indians Springs watersheds,  
Garcia River Forest.**

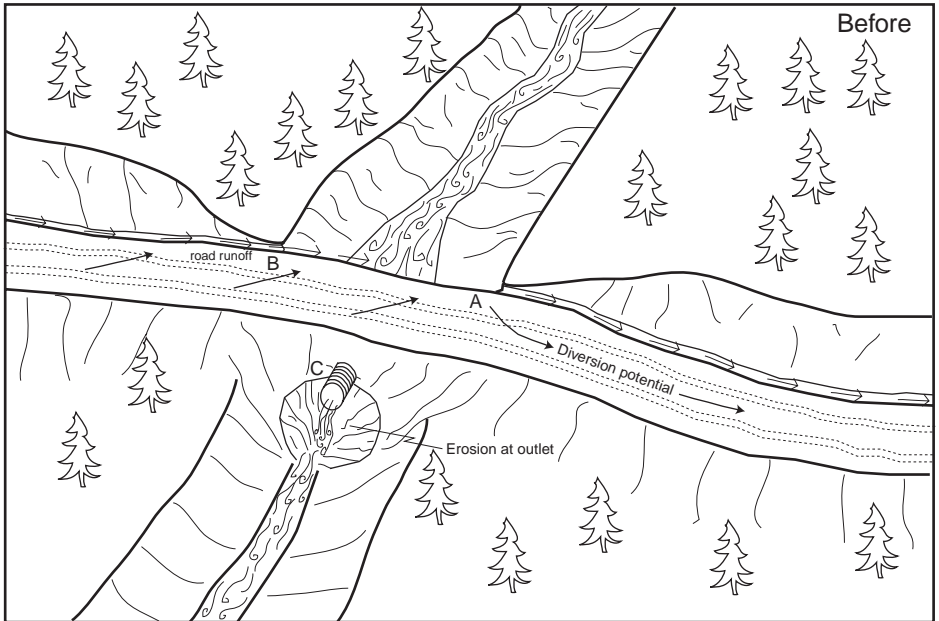
C - Undersized culvert high in fill with outlet erosion

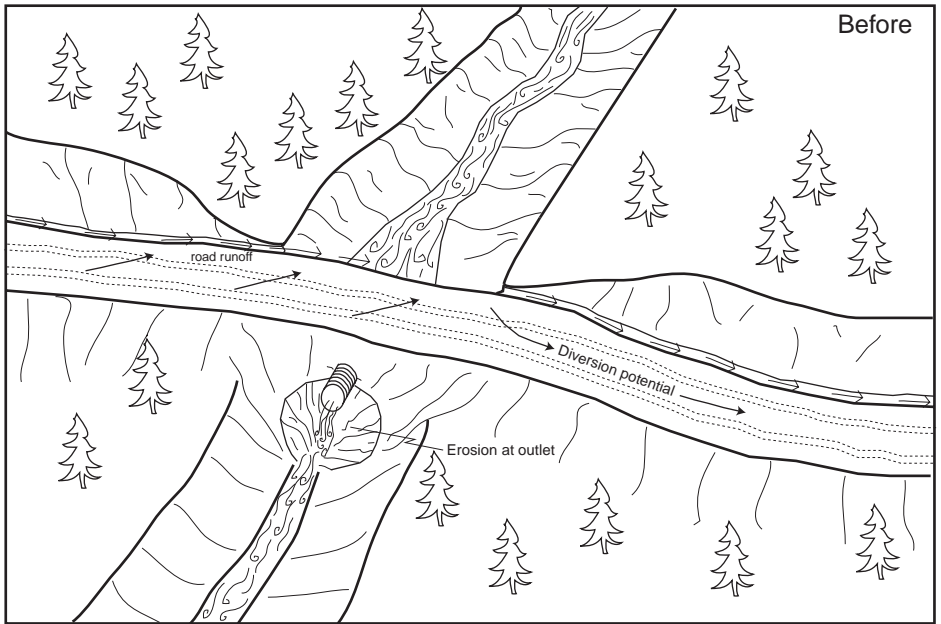
- Diversion potential
- Road surface and ditch flows drain to stream
- Undersized culvert high in fill with outlet erosion

- Road surface decompacted
- Cross road drains on old road
- Stream crossing fill completely excavated
- Excavated spoil used to outslope adjacent road

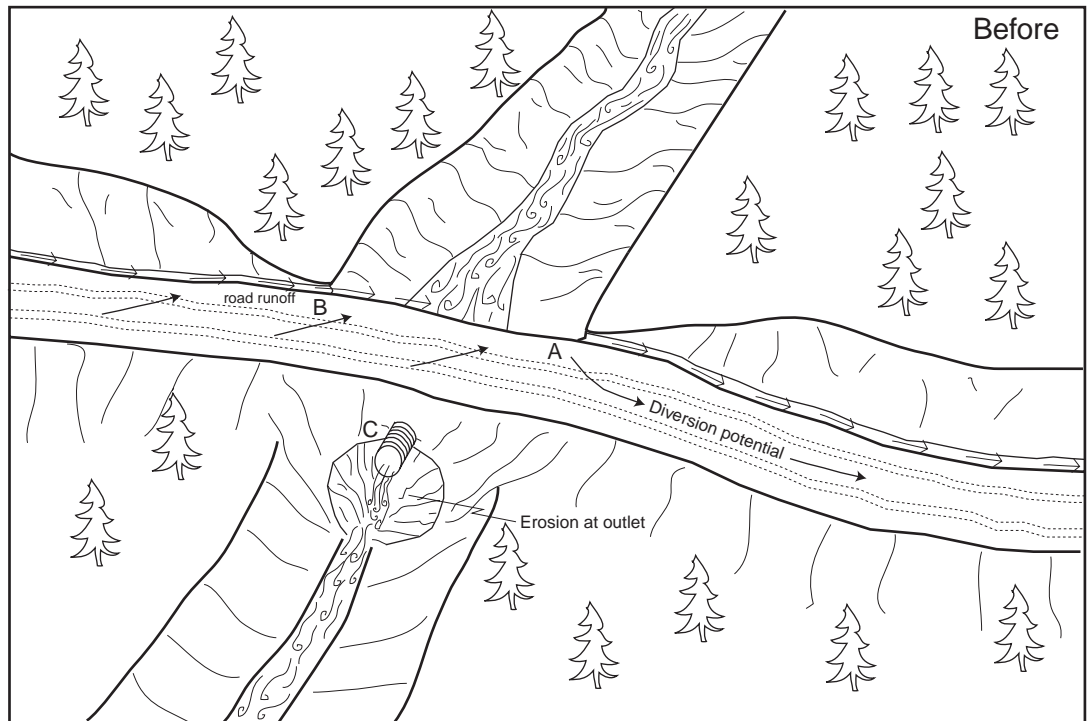
C - Undersized culvert high in fill with outlet erosion

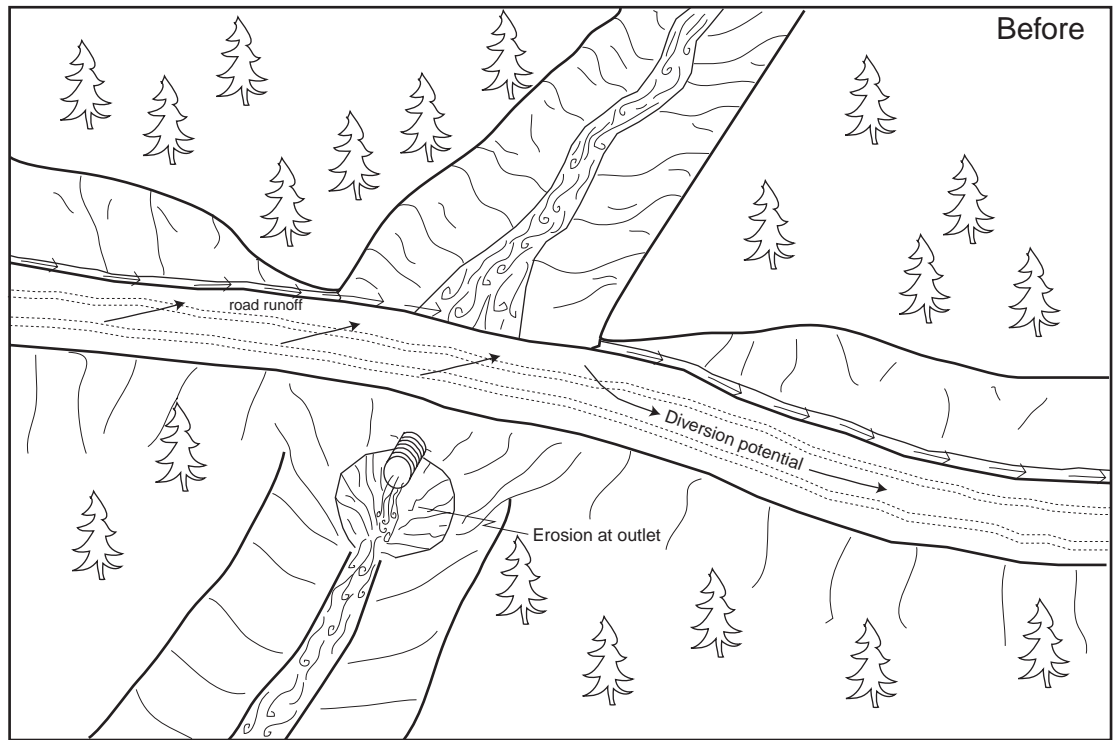
- Diversion potential
- Road surface and ditch flows drain to stream
- Undersized culvert high in fill with outlet erosion

- Road surface decompacted
- Cross road drains on old road
- Stream crossing fill completely excavated
- Excavated spoil used to outslope adjacent road
