Final Report to the NC Ecosystem Enhancement Program

North River Wetland Restoration Research

**North Carolina State University
Department of Biological and Agricultural Engineering (BAE)
Department of Soil Science (SSC)
Department of Forestry and Environmental Resources (FER)**

July 31, 2009

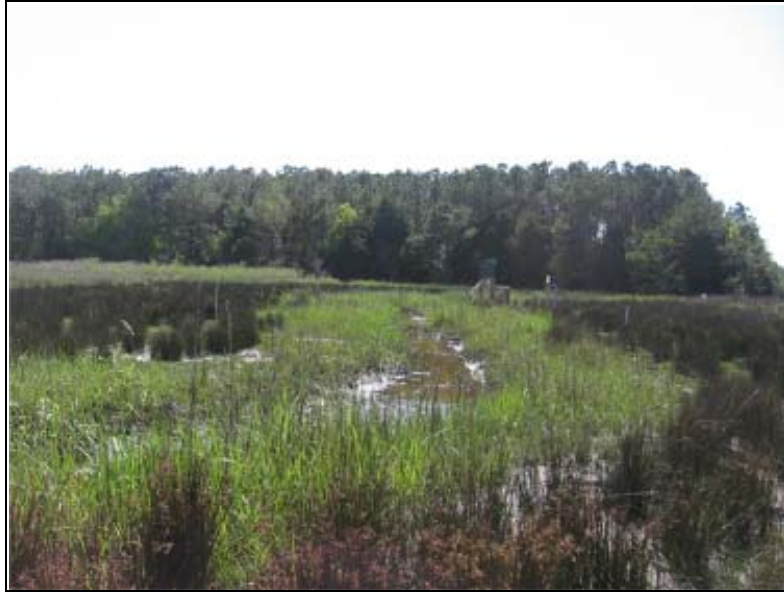
Figure 7. Photograph of the tidal marsh taken outside the research plots in 2007. Note the light green coverage of the *Spartina alterniflora* (SA) near the tidal stream and the darker green *Juncus roemerianus* (JR) in the mid-marsh. *Spartina patens* (SP) can be seen in the upper right hand side of the picture, in the upper marsh.

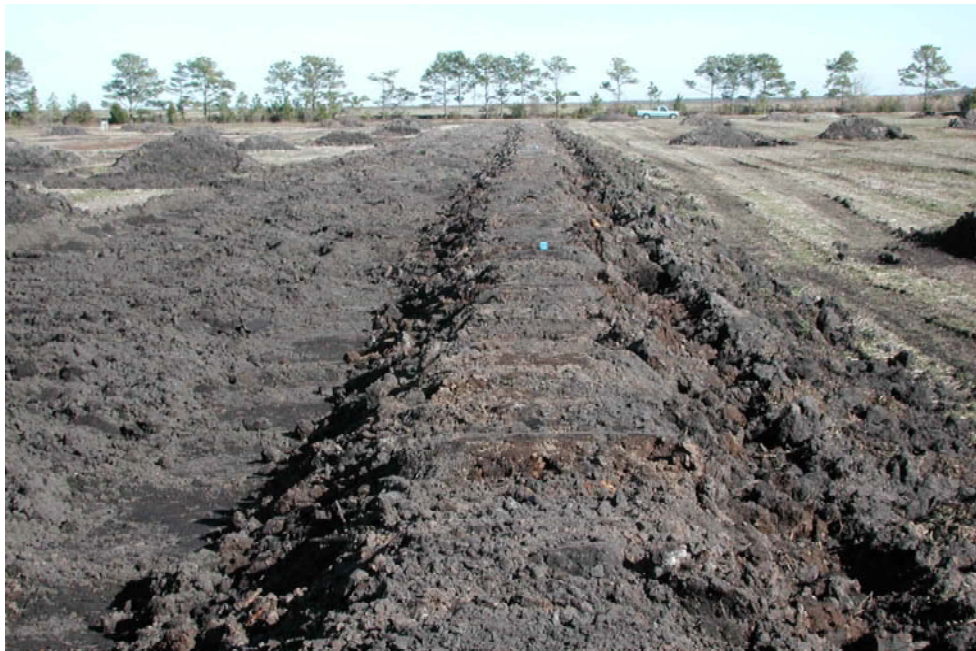
Figure 2. Berms to separate treatments, shortly after completion (Winter 2003)

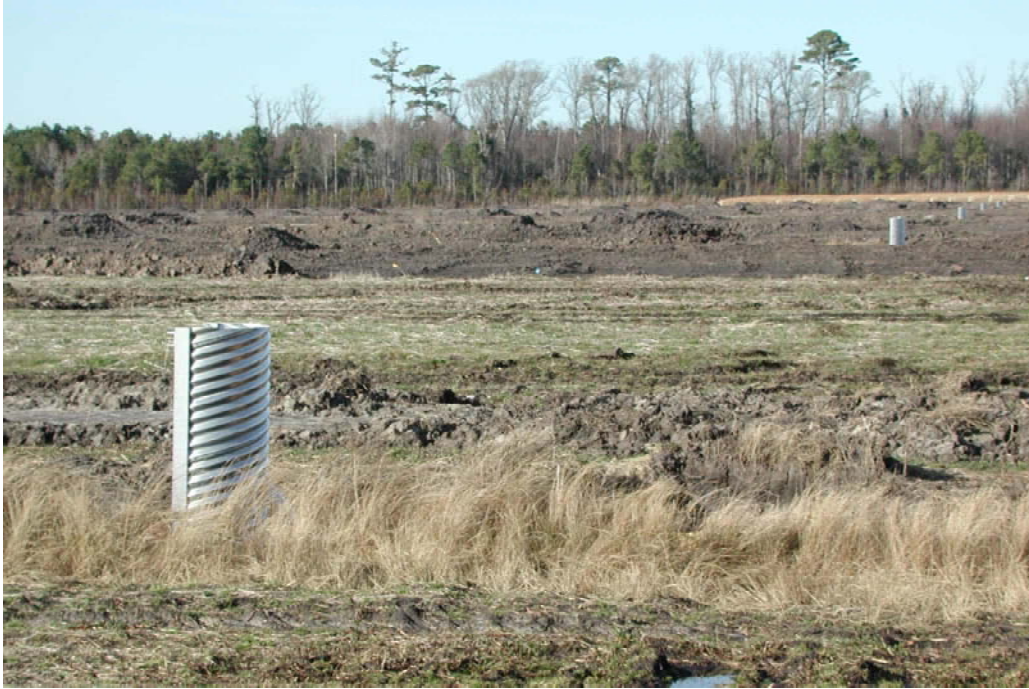
Figure 5. Water control structures (flashboard risers) shortly after installation (Winter 2003)

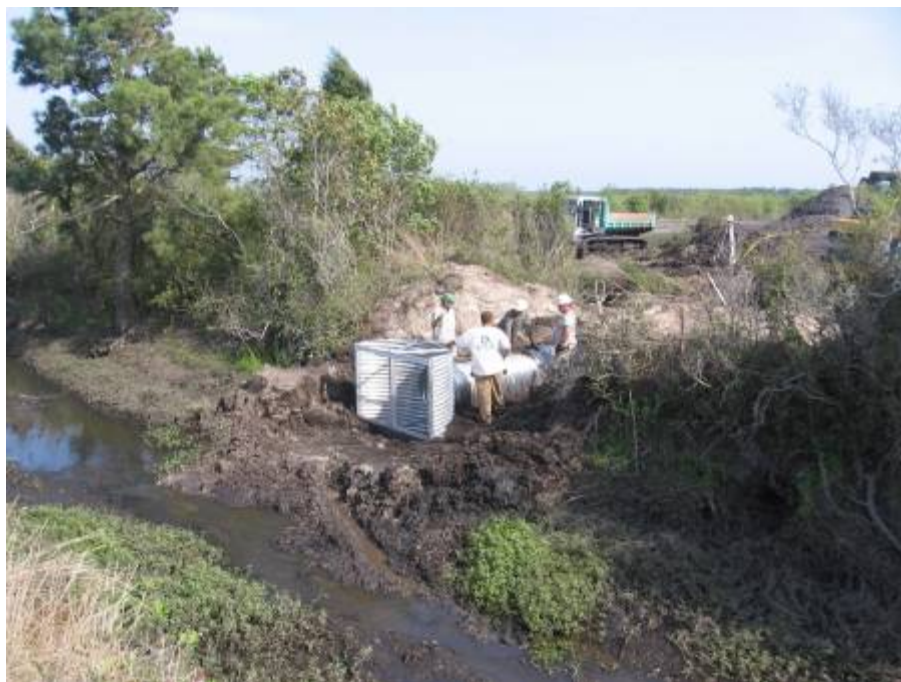
Figure 26. Installation of the water control structure that feeds the freshwater portion of the restoration (Summer 2007)

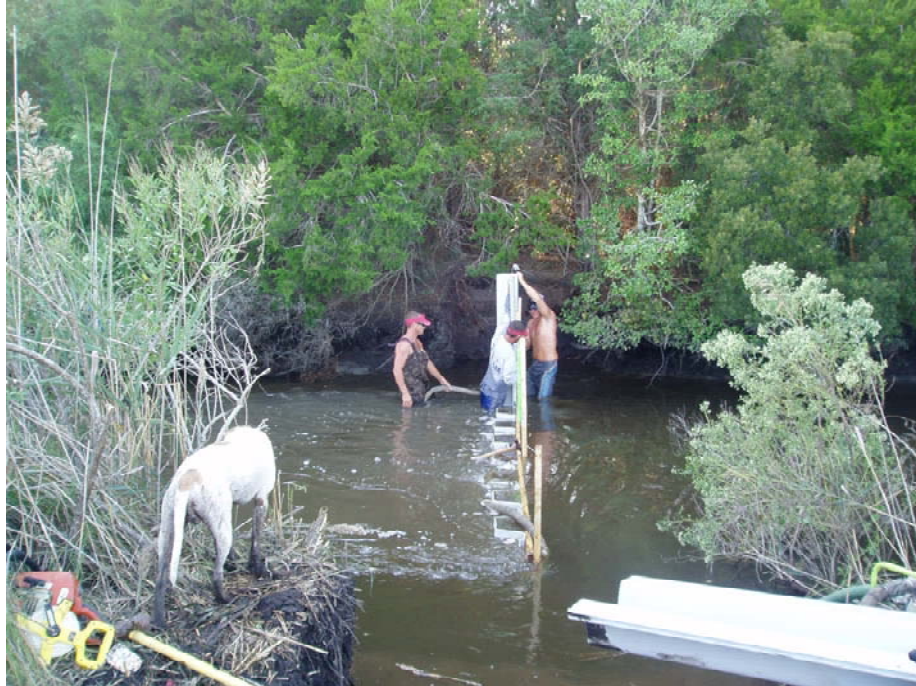
Figure 27. Installation of the low rock weir that diverted drainage water into the tidal marsh portion of the restoration (Fall 2007). Sheet piles were jetted into the canal and reinforced by marl. This design allowed for fish passage during incoming tides and during outflow events.

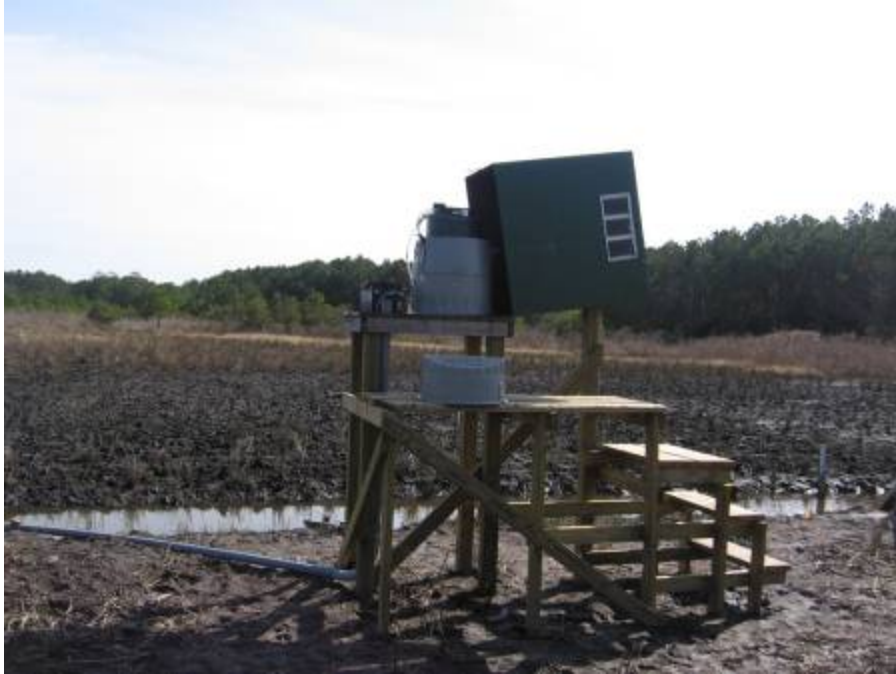
Figure 36. Close-up view of water quality and flow monitoring station shortly after marsh planting
