## Phase II 2009 Garcia River Sediment Source Assessment

Garcia River Forest,  
Mendocino County, California

PWA Report No. 10073507  
April 2010

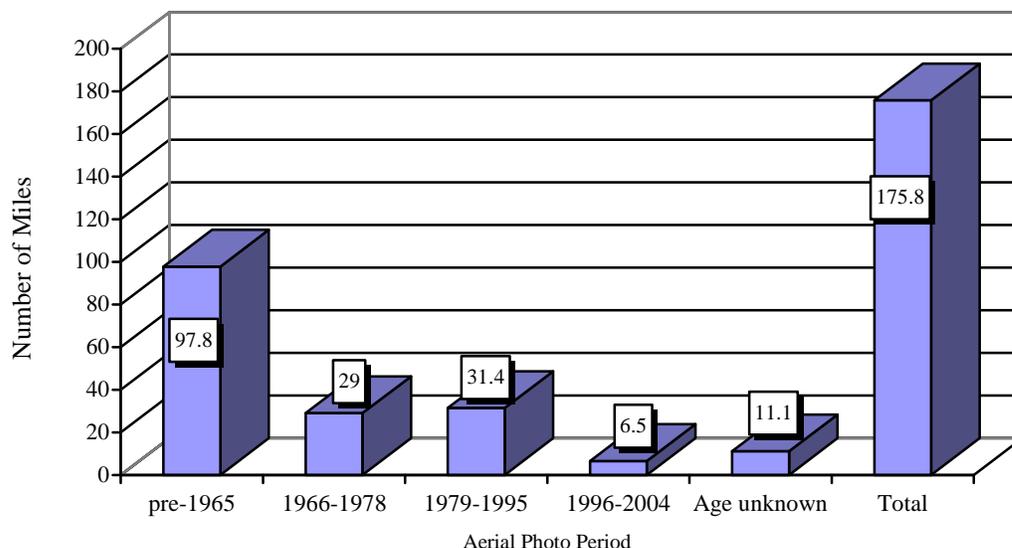
**Figure 1.** Road construction history for the area of the Garcia River Forest within the Phase II Assessment area (Mendocino County, California) based on analysis of historical aerial photographs and NAIP digital imagery.

By 1965 a total of 97.8 mi of road had been constructed in the Phase II Garcia River project area, which is 56% of the total road mileage (Figure 1). Roads constructed by 1965 include Hollow Tree Road, Graphite Road, , portions of the North Fork and Olsen Gulch Roads, and Signal Creek Road, and several associated spur roads (Map 2).

After 1965 but before 1978, an additional 29 mi of road were built in the Phase II project area, which is approximately 16% of the total road mileage (Figure 1). Roads constructed between 1965 and 1978 include the HT-4 Road, 41.3 Road, and portions of the Olsen Gulch and North Fork Roads, and spur roads used for timber harvesting in various upslope locations in the Garcia River project area (Map 2).

Approximately 6.5 mi of roads were built after 1995 and before 2004 (Figure 1, Map 2), which is approximately 4% of the total road mileage for the Phase II project area. Finally, there are approximately 11.1 mi of roads of unknown age in the Phase II Garcia River project area that were not identified on the aerial photos but were documented during field work. We conclude that these roads were either overgrown and therefore obscured on the aerial photos, or were constructed after the last aerial photo year (2004).

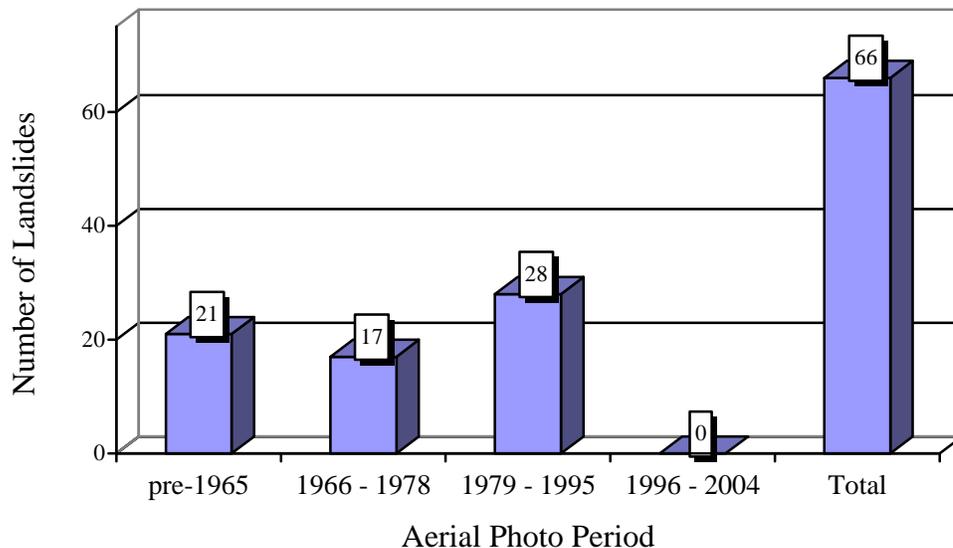
**Figure 2.** Landslide frequency distribution for the area of the Garcia River Forest within the Phase II Garcia River project area (occurrences of landslides during each of 4 time periods based on analysis of historical aerial photographs).

Numerous large storms capable of triggering mass wasting events have affected the Garcia River basin between 1956 and the present<sup>7</sup>. Examples of large storms in the Garcia River basin that are bracketed by the photography used in the aerial photo analysis occurred in 1956, 1965, 1966, 1974, 1986, and 1994. The relationship between large storms and landsliding is most evident when historic aerial photo years bracket the time of large storms. Twenty-eight (42%) of the landslides documented for the project area first appear on the 1995 photographs, which were taken just after the high peak discharge recorded in the Garcia River during the 1994 water year. In general for the project area, a large proportion of the landslides have occurred in areas where there has been extensive canopy reduction and ground disturbance from timber harvesting. The majority of the documented landslides appear to have been activated during large storm events in areas of steep topography that had been recently logged. A small number of the large landslides identified are deep seated features in the inner gorges of large channels, generated through landscape evolution processes. Our interpretation is that these deep-seated landslides are probably unrelated to land management practices

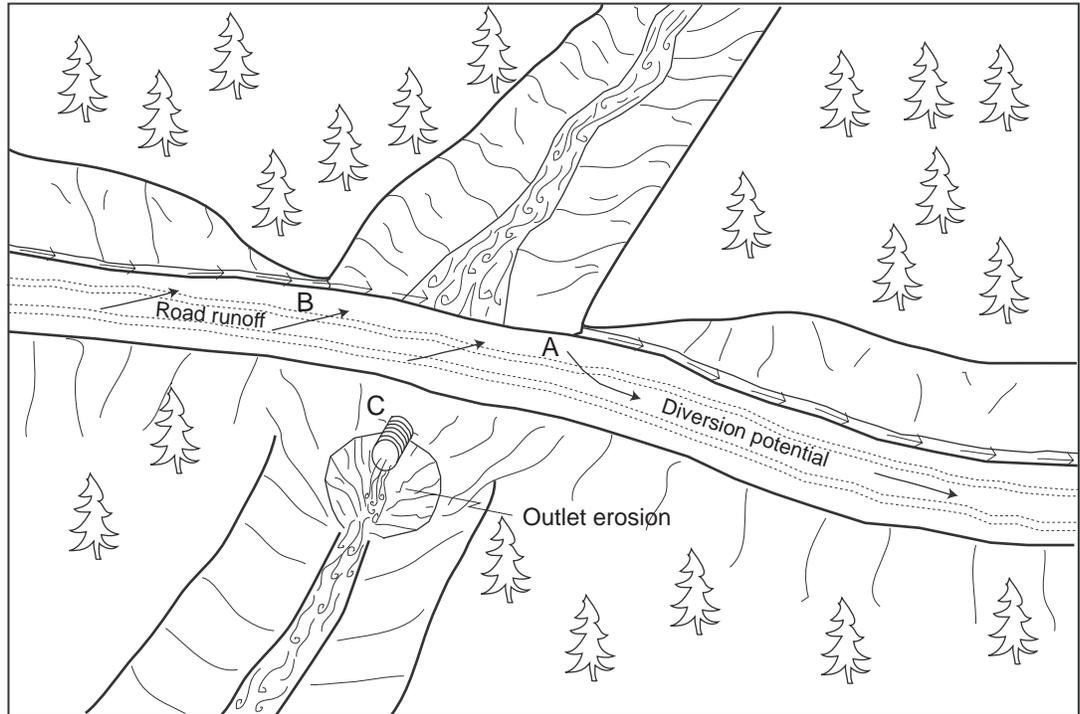
## Problem condition (before)

- A - Diversion potential
- B - Road surface and ditch drain to stream
- C - Undersized culvert high in fill with outlet erosion

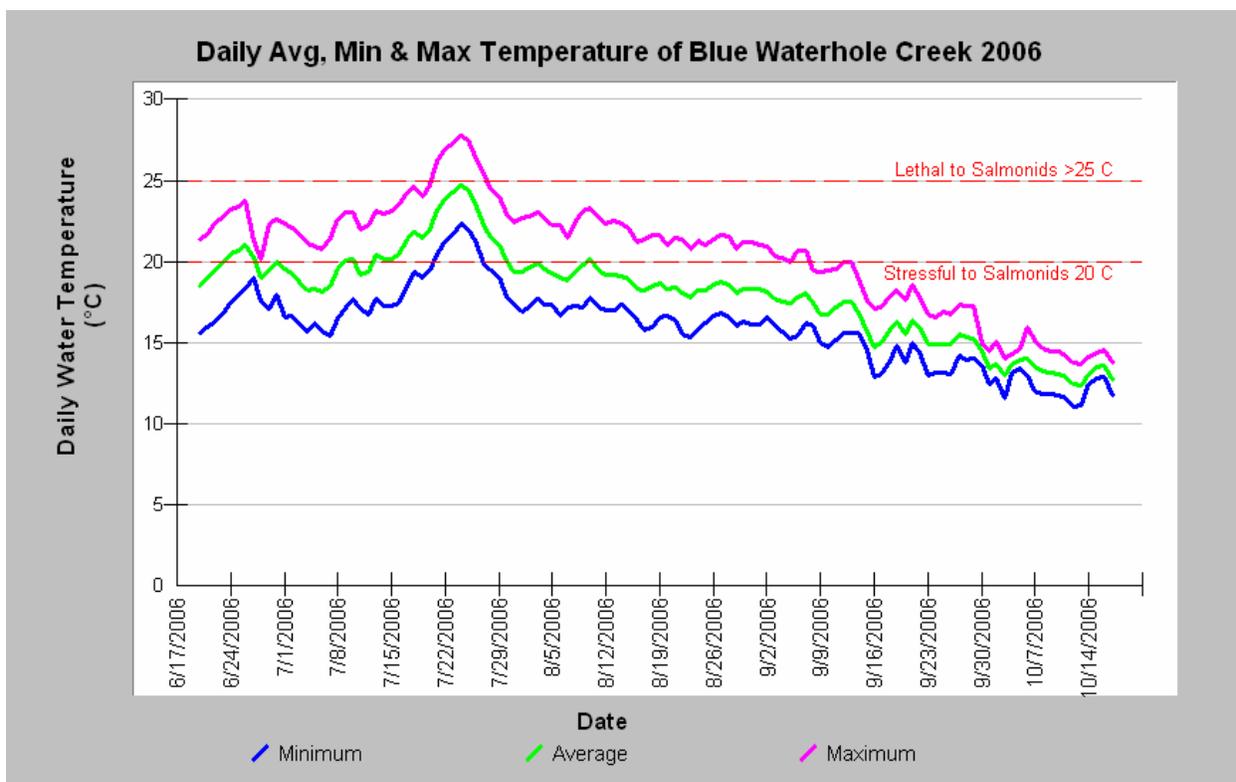
**Figure 13. Minimum, average and maximum daily water temperature of Blue Waterhole Creek at its confluence with the Garcia River showing acutely stressful or lethal temperatures for salmonids during the warmest periods of summer.**

There is the potential to form a project partnership with Landowner Stuart Bewley for upslope erosion control, riparian planting, and instream habitat improvement. Mr. Bewley owns approximately two thirds of the watershed with the Conservation Fund owning one third. Upslope stabilization, riparian planting and temperature improvement should proceed before any large wood or other instream structures are considered. Reductions in stream temperatures in Blue Waterhole over time would greatly increase the production of steelhead and could have a significant effect of cooling the main stem Garcia River immediately downstream of the confluence.
