**Final Report:  
The Conservation Fund  
Garcia River Forest Phase 1 Assessment  
Mendocino County, California**

PWA Report #08068303  
March, 2008

**CDFG Fisheries Restoration Grant Program  
Salmon and Steelhead Trout Restoration Account  
Contract #P0430414**

**Long term road drainage and  
erosion control plan for the  
Inman Creek and Indians Springs watersheds,  
Garcia River Forest.**

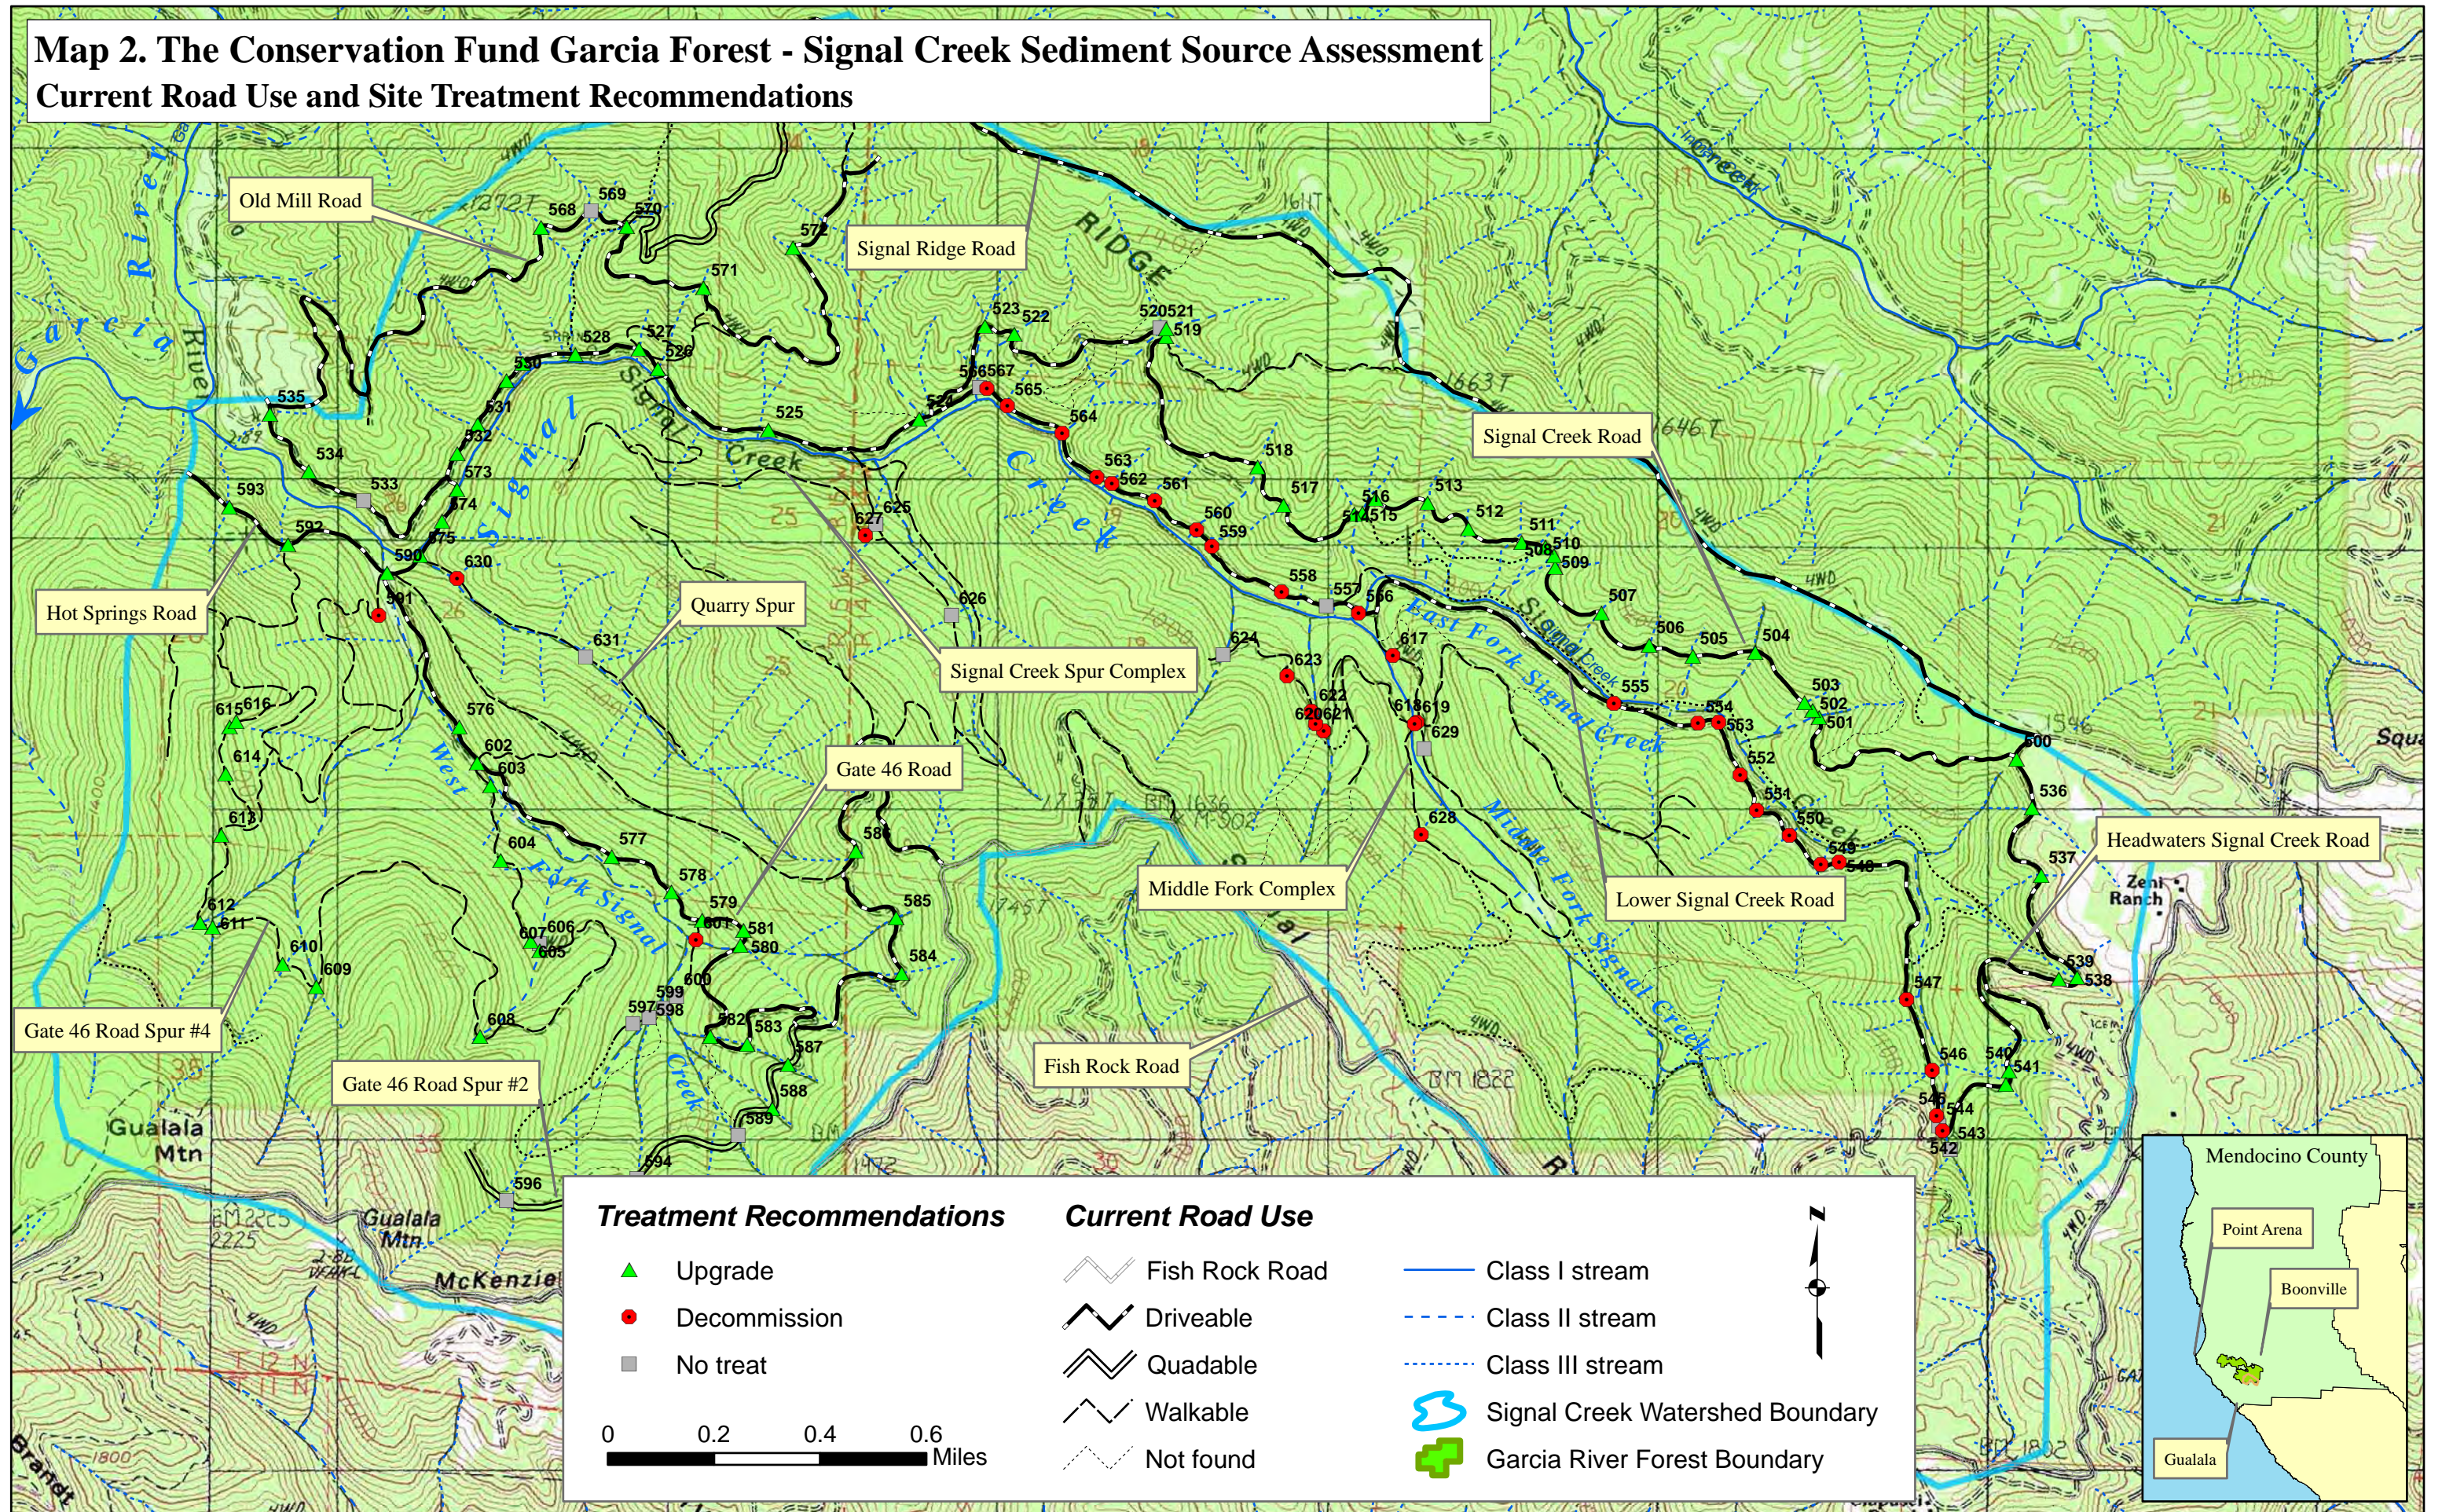
# Map 2. The Conservation Fund Garcia Forest - Signal Creek Sediment Source Assessment

## Current Road Use and Site Treatment Recommendations
