**2009 Big Salmon Creek
Sediment Source Assessment Project
Mendocino County, California**

PWA Report No. 10086301
March 2010

**CDFG Fisheries Restoration Grant Program
Salmon and Steelhead Trout Restoration Account
Contract #P0810300**

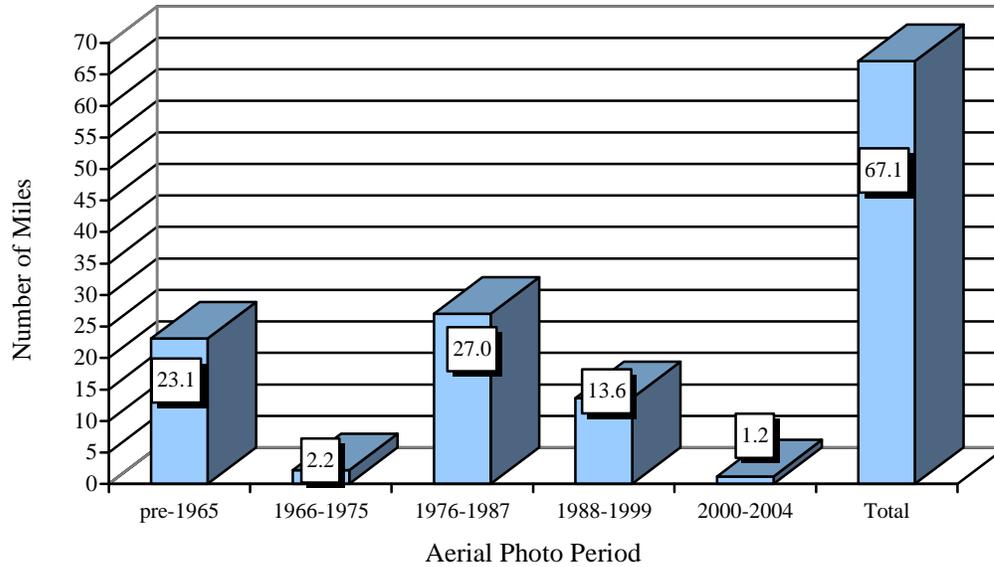
Figure 1. Road construction history for the The Conservation Fund ownership in the Big Salmon Creek watershed (Mendocino County, California) based on analysis of historical aerial photographs and NAIP digital imagery.

Using aerial photographs and NAIP digital imagery, PWA developed a history of road construction in the project area for 5 time periods: pre-1965, 1966-1975, 1976-1987, 1988-1999, 2000-2004, and 2005 (Figure 1, Map 2). Our measurements show that a total of approximately 67.1 mi of roads were constructed within the project area by 2004 (Figure 1). PWA inventoried all 67.1 mi of road in the project area. It should be noted that the road construction history reflects second growth logging throughout the Big Salmon Creek watershed. The entire area was previously logged around the turn of the 20th century utilizing railroads and steam donkey yarding methods.

By 1965 a total of 23.1 mi of road had been constructed in the project area, which is 34% of the total road mileage (Figure 1). This includes the roads and/or railroads constructed along the length of the low gradient mainstem Big Salmon Creek, Hazel Gulch, the Elliot and Iron Gate Roads, and the ridgetop roads between Hazel Gulch and the Albion River watershed (Roads 27000, 26000, 26020, 27000, 27200, 29000, 29100, and 29121) (Map 2).

Between 1965 and 1975, an additional 2.2 mi of roads were built in the project area, which is approximately 3% of the total road mileage (Figure 1). Roads constructed between 1965 and 1975 include short spur roads used for timber harvesting in various channel valley locations in the headwaters of Hazel Gulch and the reentry to Pullen Gulch (Map 2).

Approximately 40% of the roads identified in the project area (27 mi) were constructed between 1976 and 1987 to access logging operations in Donnelly Gulch, northwest Hazel Gulch, and the northern slopes of mainstem Big Salmon Creek (Figure 1, Map 2). In addition to the extensive mainline logging roads located in subwatershed valleys, networks of midslope spurs extending from ridgetop mainline access roads were also constructed at this time.

Approximately 13.6 mi of road were constructed between 1988 and 1999, which is approximately 20% of the total road mileage identified in the project area. Roads and landings constructed during this time period are generally upslope extensions of previously constructed road networks and are primarily associated with cable logging practices (Figure 1, Map 2).

Finally, approximately 1.2 mi of roads were constructed between 1999 and 2004, which accounts for approximately 1.7% of the total road mileage identified in the project area. Roads constructed during this time period are small extensions of existing road networks (Figure 1, Map 2). There were no additional roads identified on the 2005 NAIP imagery.

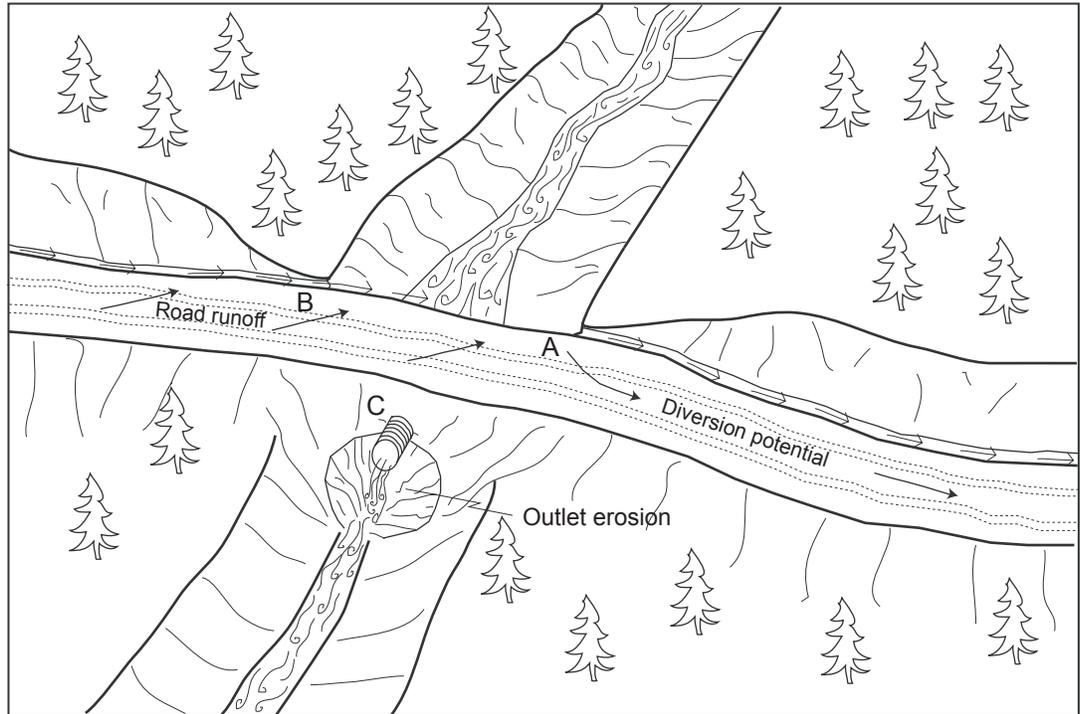
Problem condition (before)

- A - Diversion potential
- B - Road surface and ditch drain to stream
- C - Undersized culvert high in fill with outlet erosion

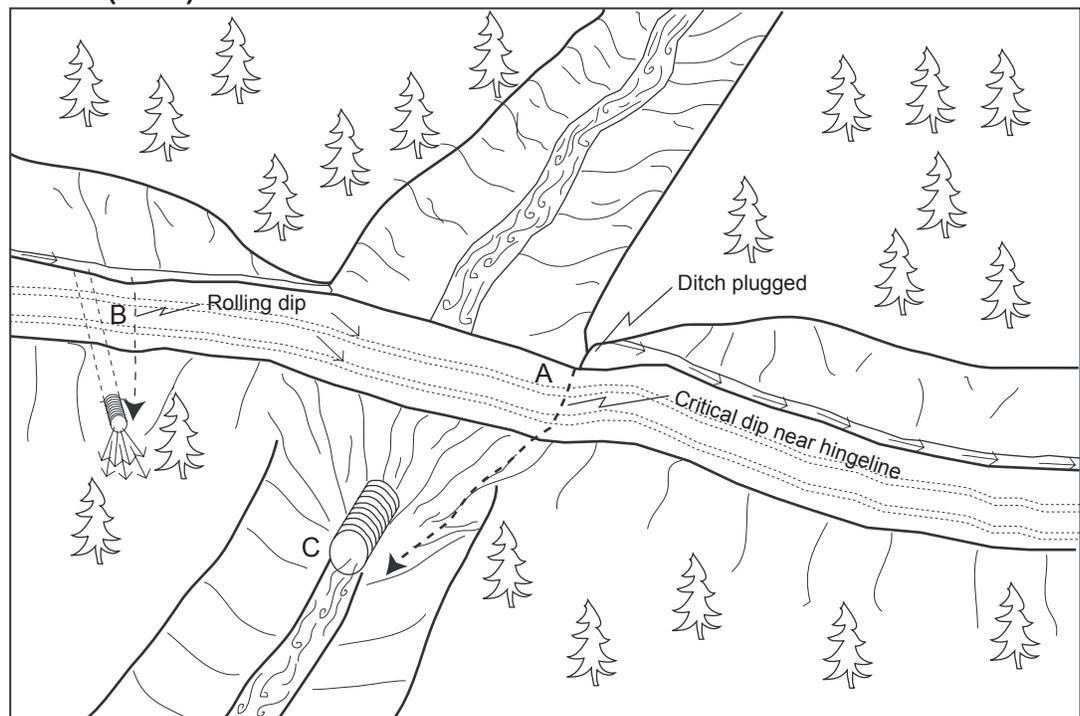
Treatment standards (after)

- A - No diversion potential with critical dip installed near hingeline
- B - Road surface and ditch disconnected from stream by rolling dip and ditch relief culvert
- C - 100-year culvert set at base of fill

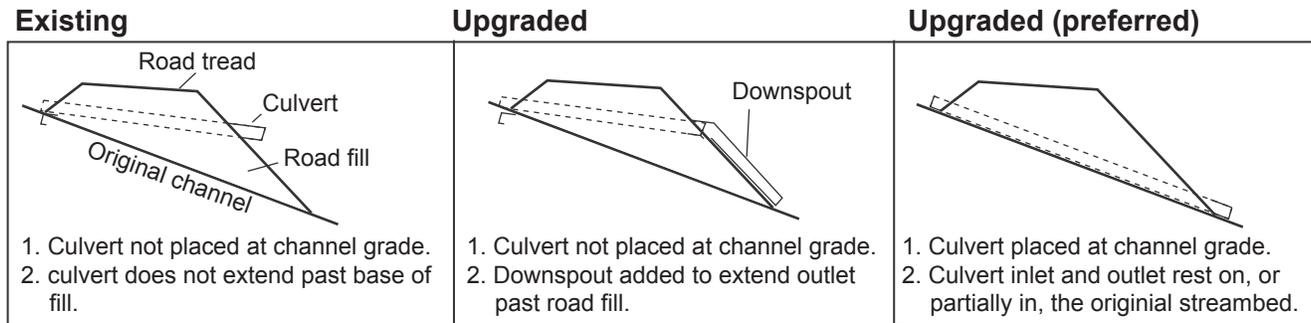
Typical Design of a Non-fish Bearing Culverted Stream Crossing

Road upgrading tasks typically include upgrading stream crossings by installing larger culverts and inlet protection (trash barriers) to prevent plugging. Culvert sizing for the 100-year peak storm flow should be determined by both field observation and calculations using a procedure such as the Rational Formula.

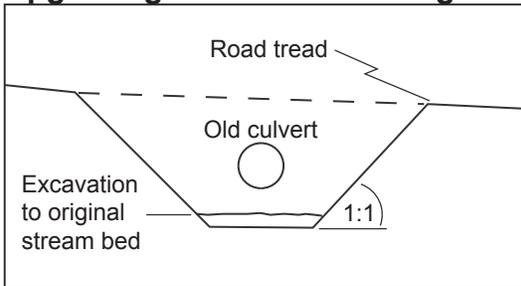
Excavation in preparation for upgrading culverted crossing

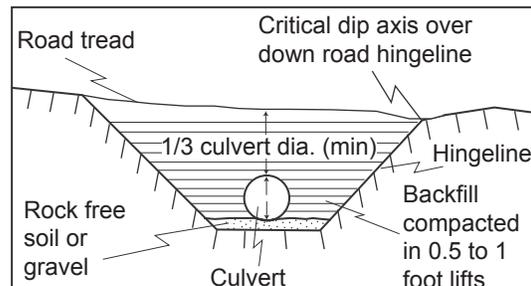
Upgraded stream crossing culvert installation

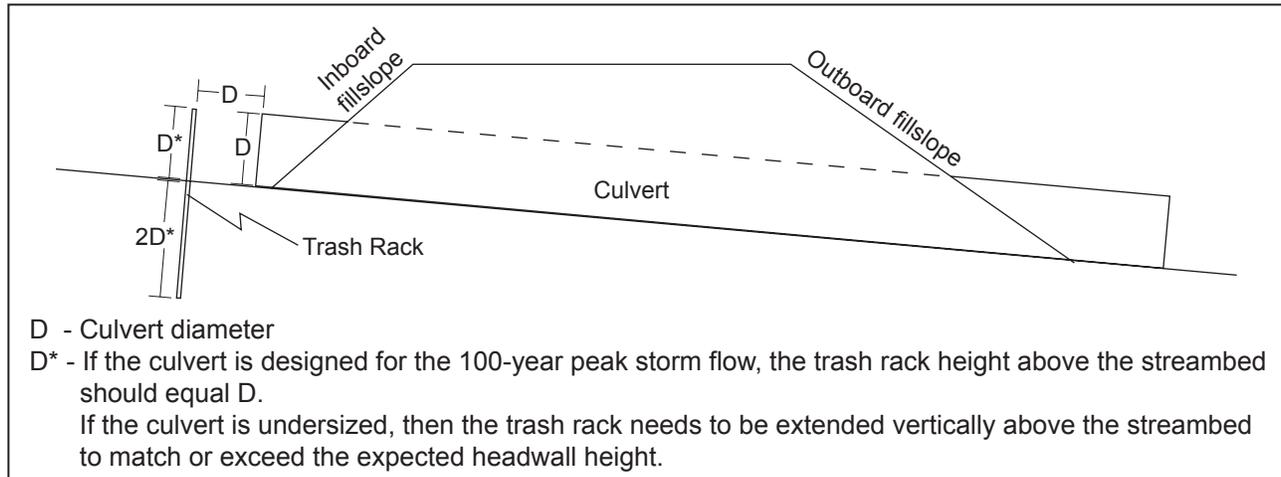
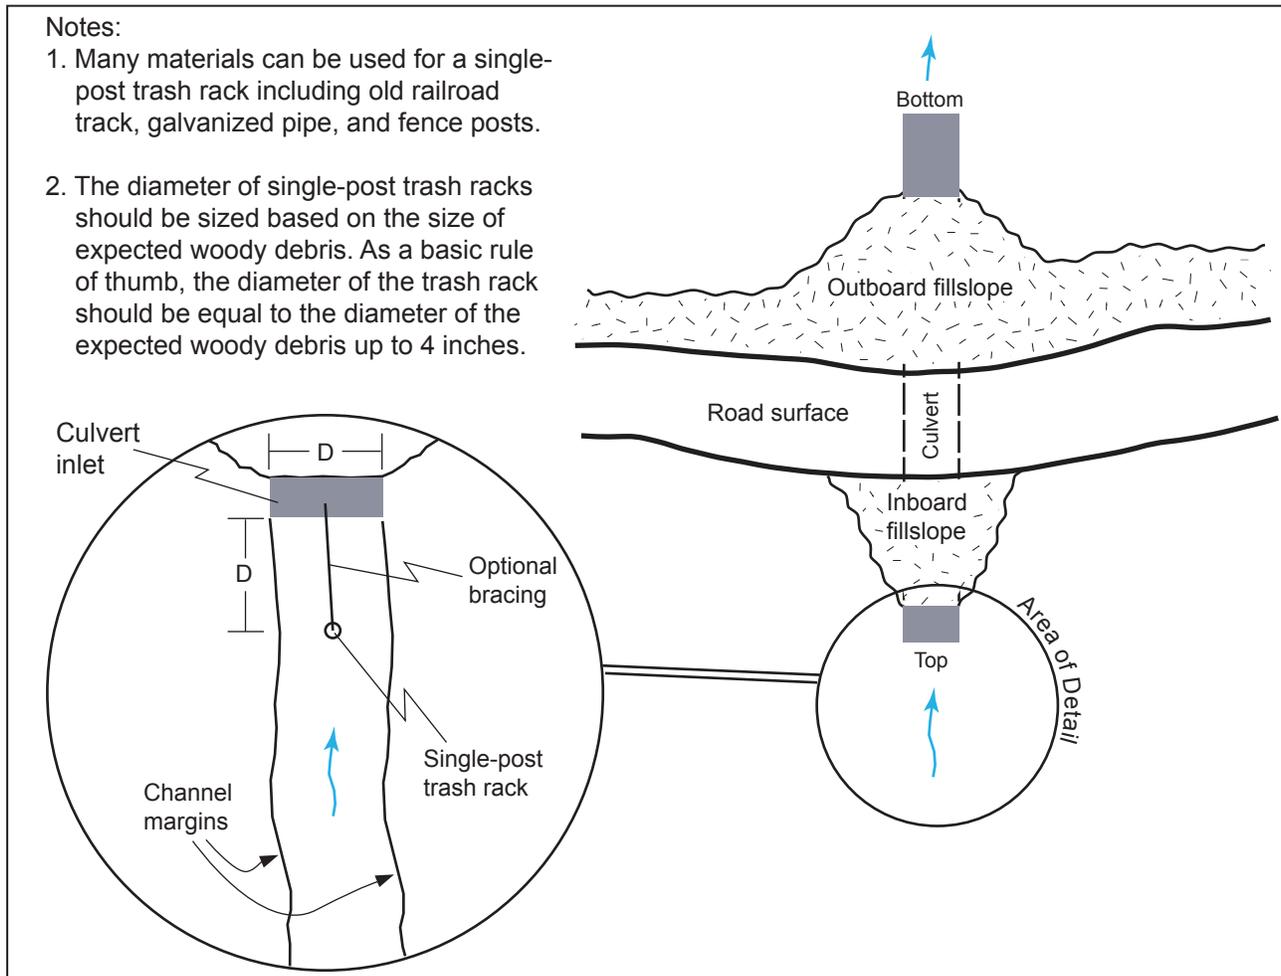
Typical Design of a Single-post Culvert Inlet Trash Rack

Cross section view

Plan view

1. Many materials can be used for a single-post trash rack including old railroad track, galvanized pipe, and fence posts.
2. The diameter of single-post trash racks should be sized based on the size of expected woody debris. As a basic rule of thumb, the diameter of the trash rack should be equal to the diameter of the expected woody debris up to 4 inches.

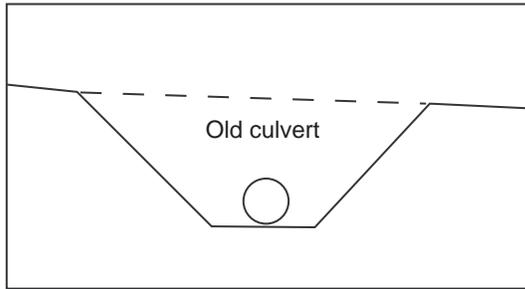
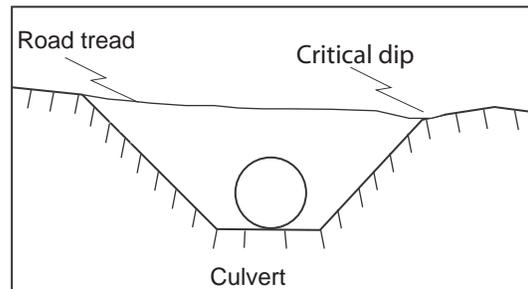
Typical Design of Upgraded Stream Crossings

Stream crossing culvert Installation

1. Culverts shall be aligned with natural stream channels to ensure proper function, and prevent bank erosion and plugging by debris.
2. Culverts shall be placed at the base of the fill and the grade of the original streambed or downspouted past the base of the fill.

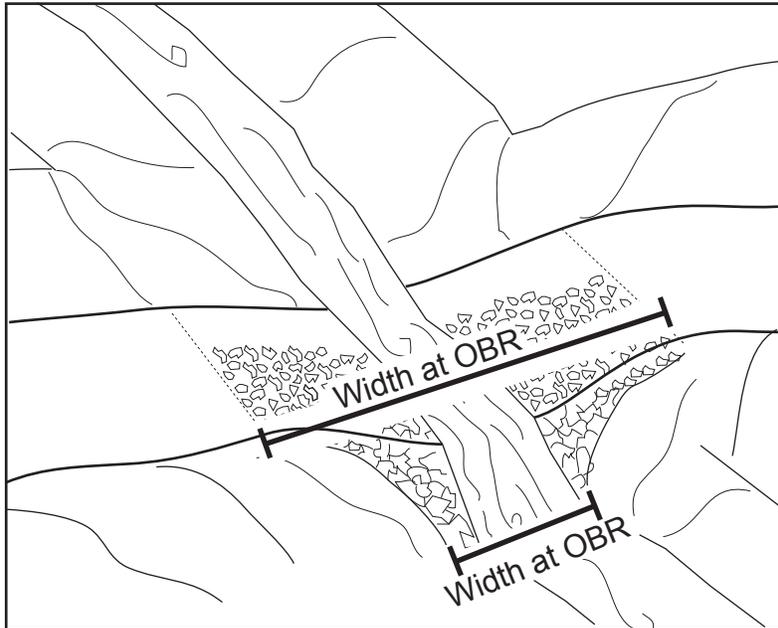
Widths in oblique view

OBR - Outboard edge of road

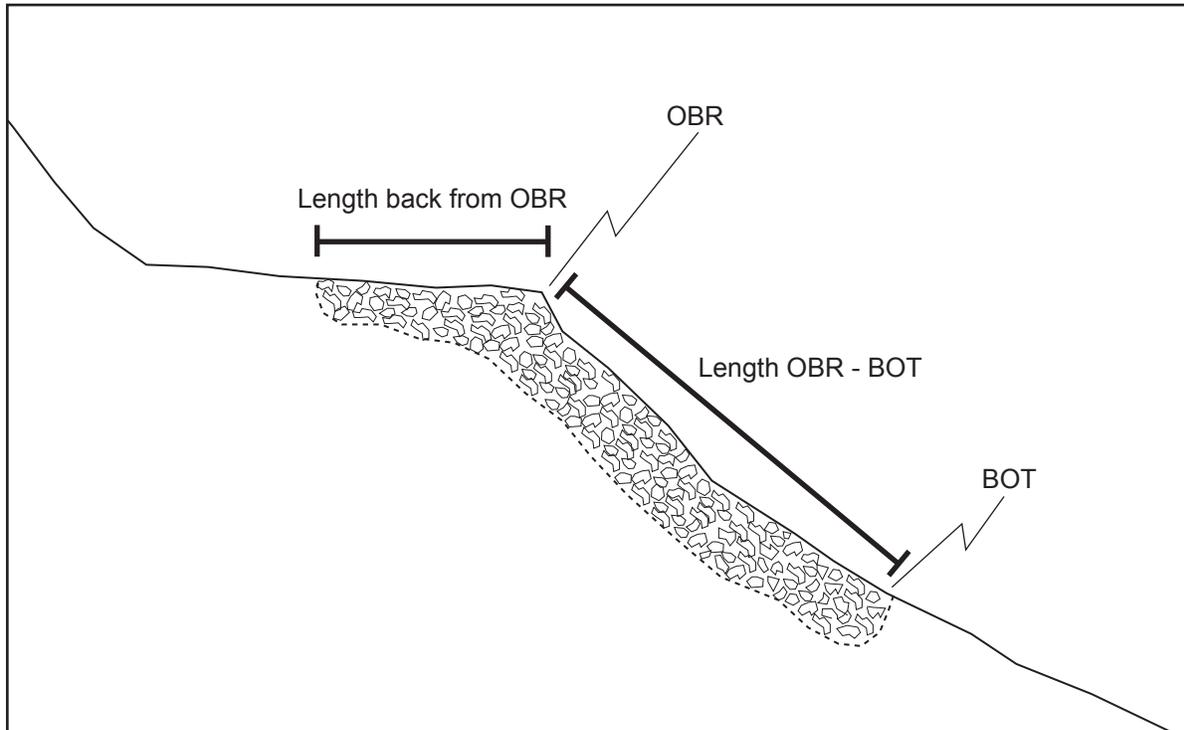
Lengths in profile view

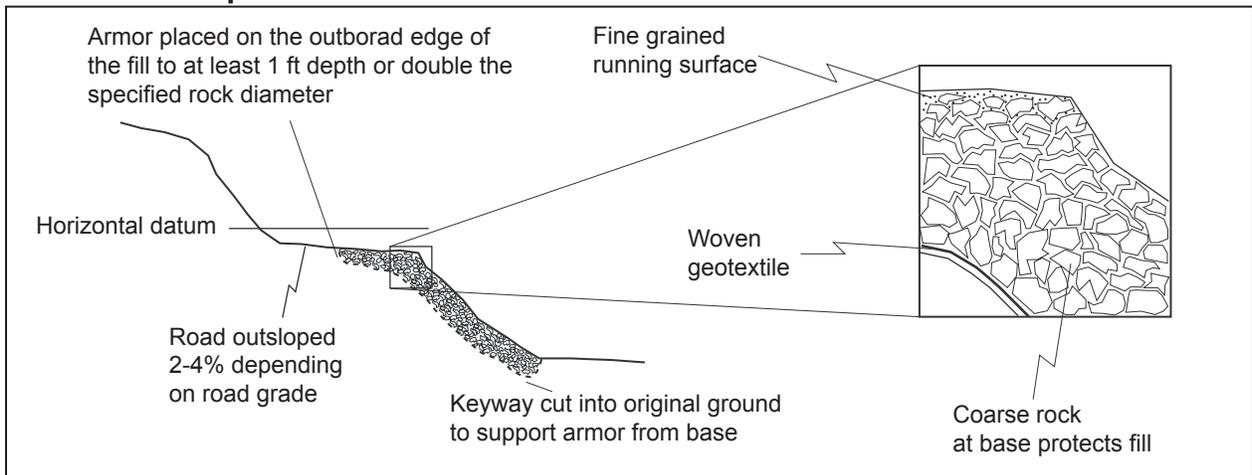
Cross section parallel to watercourse

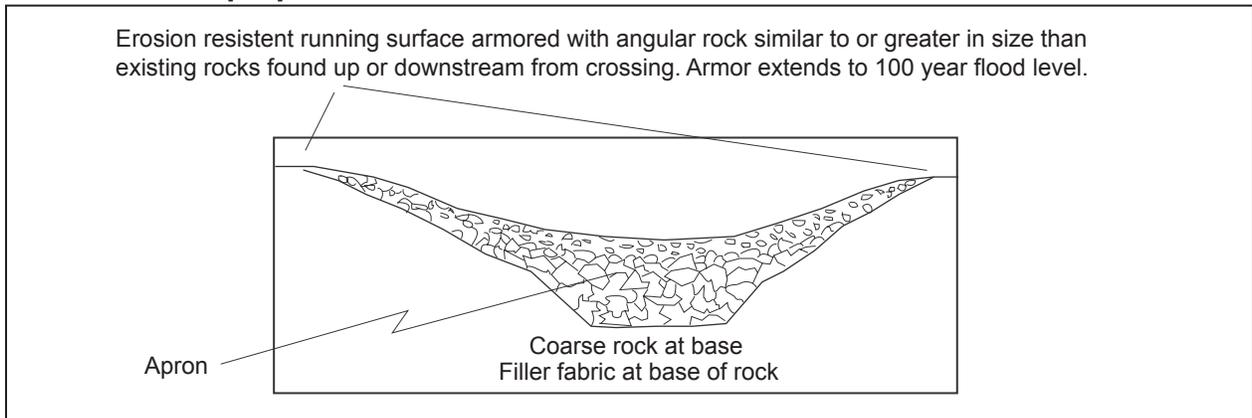
Cross section perpendicular to watercourse

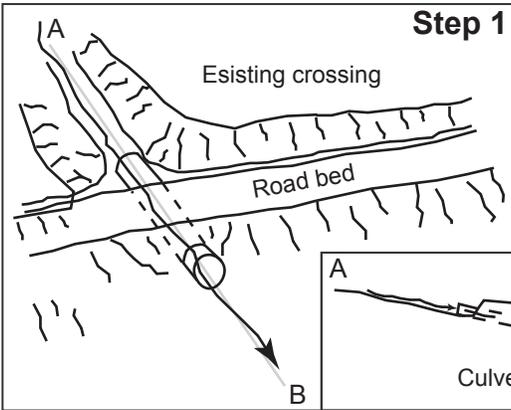
Step 1

- The two most important points are:
 - The rock must be placed in a "U" shape across the channel to confine flow within the armored area.** (Flow around the rock armor will gully the remaining fill. Proper shape of surrounding road fill and good rock placement will reduce the likelihood of crossing failure).
 - The largest rocks must be used to buttress the rest of the armor in two locations:** (i) The base of the armored fill where the fill meets natural channel. (This will buttress the armor placed on the outboard fill face and reduce the likelihood of it washing downslope). (ii) The break in slope from the road tread to the outer fill face. (This will buttress the fill placed on the outer road tread and will determine the "base level" of the creek as it crosses the road surface).

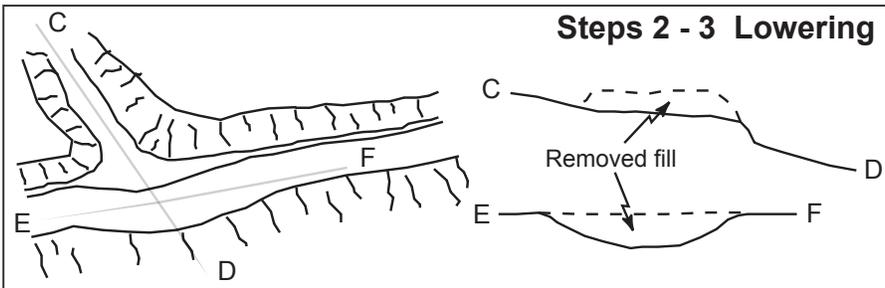
Steps 2 - 3 Lowering

- Remove any existing drainage structures** including culverts and Humboldt logs.
- Construct a dip** centered at the crossing that is large enough to accommodate the 100-year peak storm flow and prevent diversion (C-D, E-F).

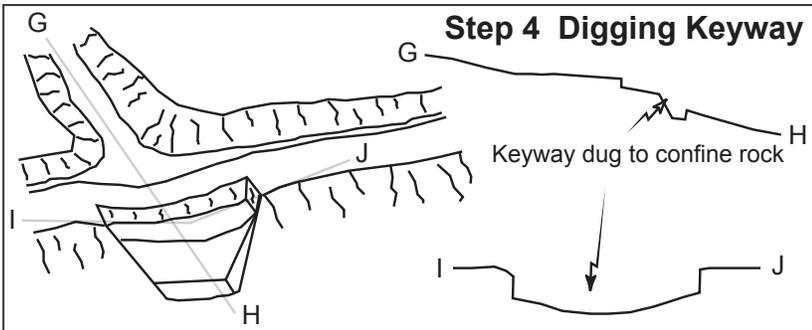
Step 4 Digging Keyway

- Dig a keyway** (to place rock in) that extends from the outer 1/3 of the road tread down the outboard road fill to the point where outboard fill meets natural channel (up to 3 feet into the channel bed depending on site specifics) (G-H, I-J).
- Install geofabric (optional)** within keyway to support rock in wet areas and to prevent winnowing of the crossing at low flows.

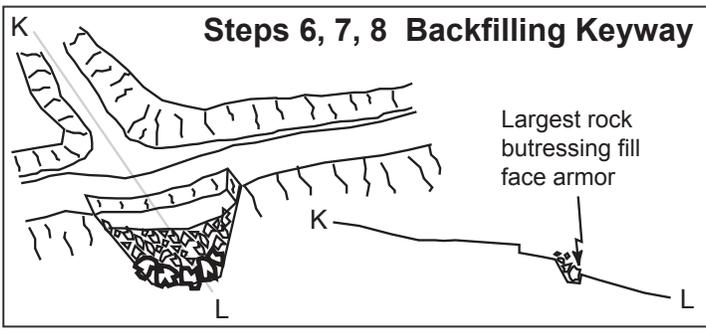
Steps 6, 7, 8 Backfilling Keyway

- Put aside the largest rock** armoring to create 2 buttresses in the next step.
- Create a buttress using the largest rock** (as described in the site treatments specifications) at the base of fill. (This should have a "U" shape to it and will define the outlet of the armored fill.)
- Backfill the fill face** with remaining rock armor making sure the final armored area has "U" shape that will accommodate the largest expected flow (K-L).

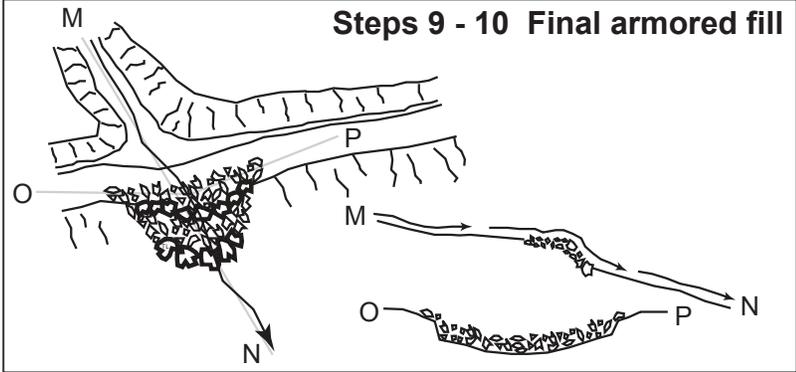
Steps 9 - 10 Final armored fill

- Install a second buttress** at the break in slope between the outboard road and the outboard fill face. (This should define the base level of the stream and determine how deep the stream will backfill after construction). (M-N)
- Back fill the rest of the keyway** with the unsorted rock armor making sure the final armored area has a "U" shape that will accommodate the largest expected flow (O-P).

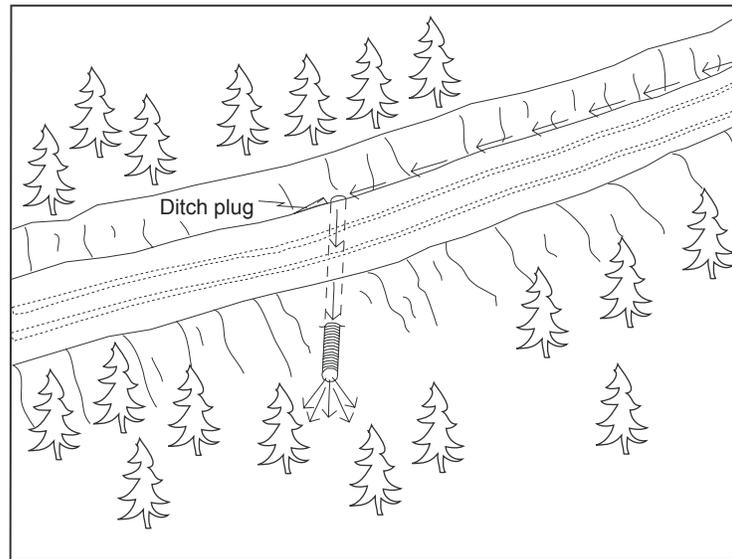
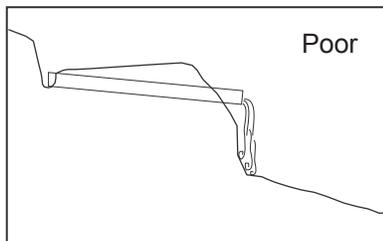
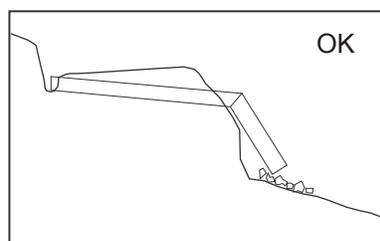
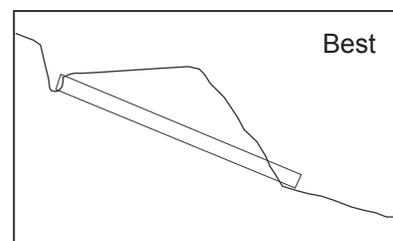
Typical Ditch Relief Culvert Installation

Ditch relief culvert installation

- 1) The same basic steps followed for stream crossing installation shall be employed.
- 2) Culverts shall be installed at a 30 degree angle to the ditch to lessen the chance of inlet erosion and plugging.
- 3) Culverts shall be seated on the natural slope or at a minimum depth of 5 feet at the outside edge of the road, whichever is less.
- 4) At a minimum, culverts shall be installed at a slope of 2 to 4 percent steeper than the approaching ditch grade, or at least 5 inches every 10 feet.
- 5) Backfill shall be compacted from the bed to a depth of 1 foot or 1/3 of the culvert diameter, which ever is greater, over the top of the culvert.
- 6) Culvert outlets shall extend beyond the base of the road fill (or a flume downspout will be used).
Culverts will be seated on the natural slope or at a depth of 5 feet at the outside edge of the road, whichever is less.

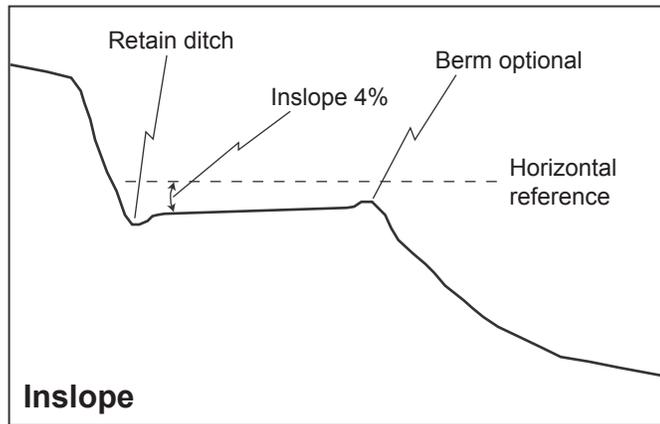
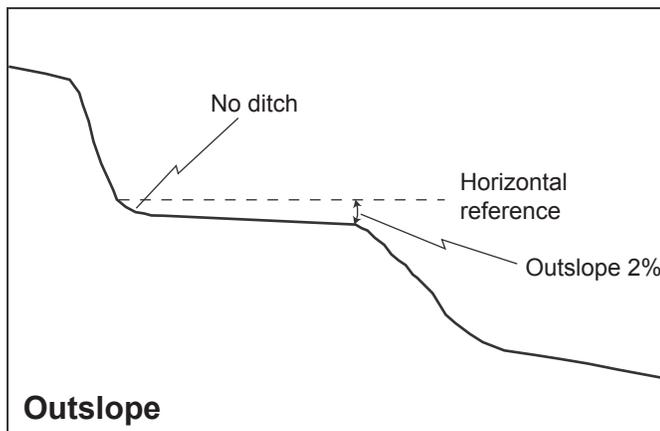
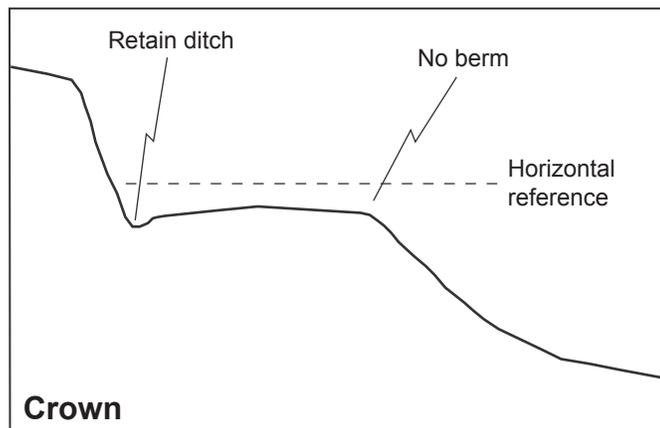
Typical Designs for Using Road Shape to Control Road Runoff

Outsloping Pitch for Roads Up to 8% Grade		
Road grade	Unsurfaced roads	Surfaced roads
4% or less	3/8" per foot	1/2" per foot
5%	1/2" per foot	5/8" per foot
6%	5/8" per foot	3/4" per foot
7%	3/4" per foot	7/8" per foot
8% or more	1" per foot	1 1/4" per foot

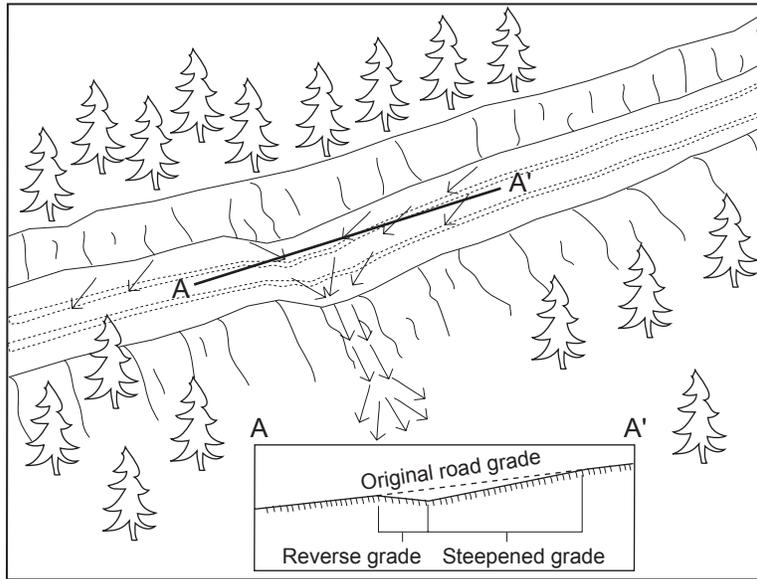
Typical Road Surface Drainage by Rolling Dips

Rolling dip installation:

1. Rolling dips will be installed in the roadbed as needed to drain the road surface.
2. Rolling dips will be sloped either into the ditch or to the outside of the road edge as required to properly drain the road.

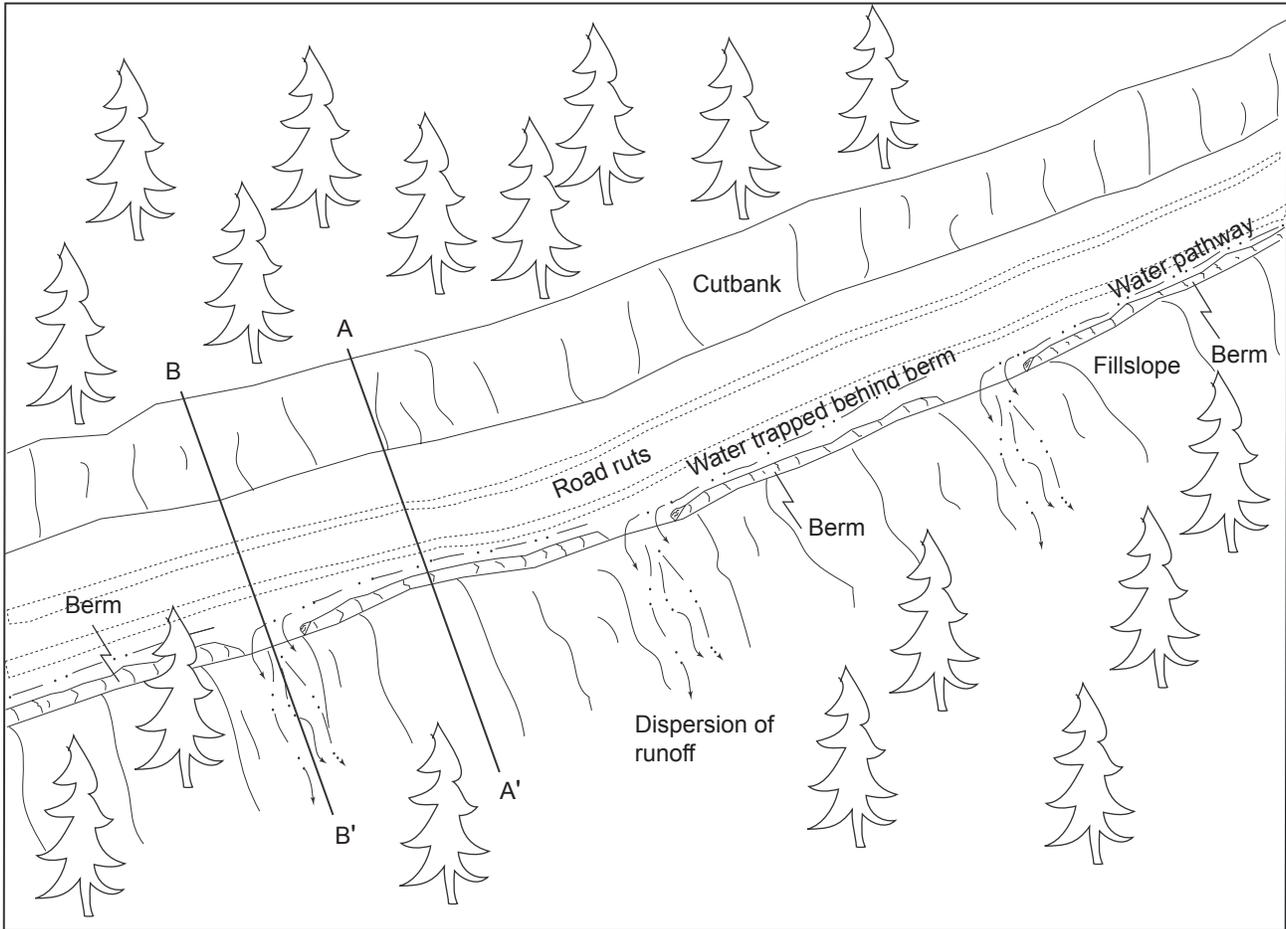
Typical Sidecast or Excavation Methods for Removing Outboard Berms on a Maintained Road

1. On gentle road segments berms can be removed continuously (see B-B').
2. On steep road segments, where safety is a concern, the berm can be frequently breached (see A-A' & B-B').
Berm breaches should be spaced every 30 to 100 feet to provide adequate drainage of the road system while maintaining a semi-continuous berm for vehicle safety.

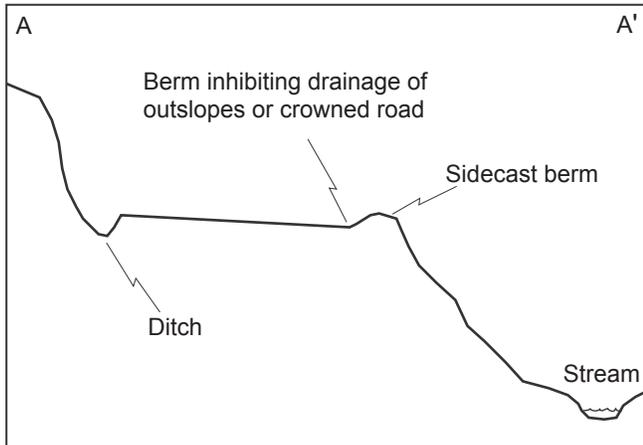
Road cross section between berm breaches

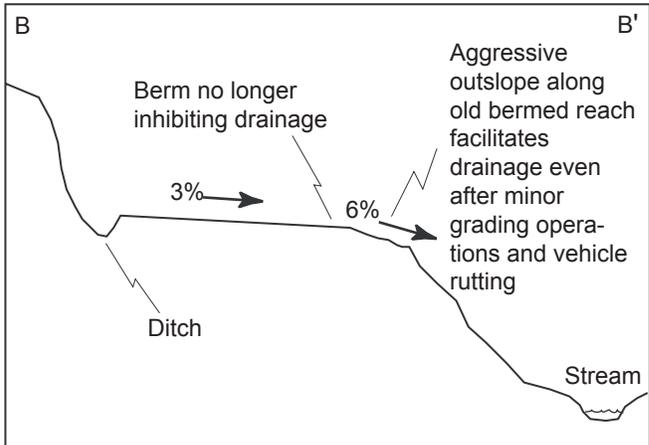
Road cross section at berm breaches

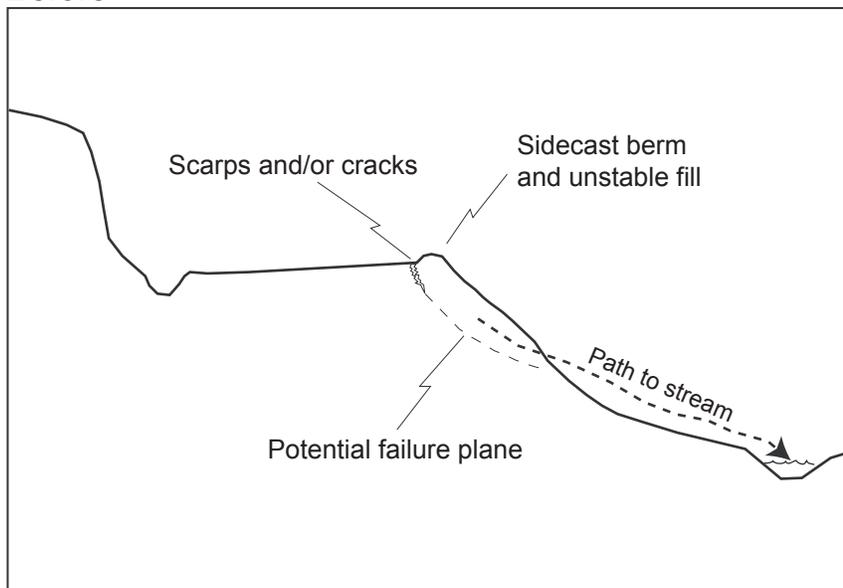
Before

Typical Excavation of Unstable Fillslope on an Upgraded Road

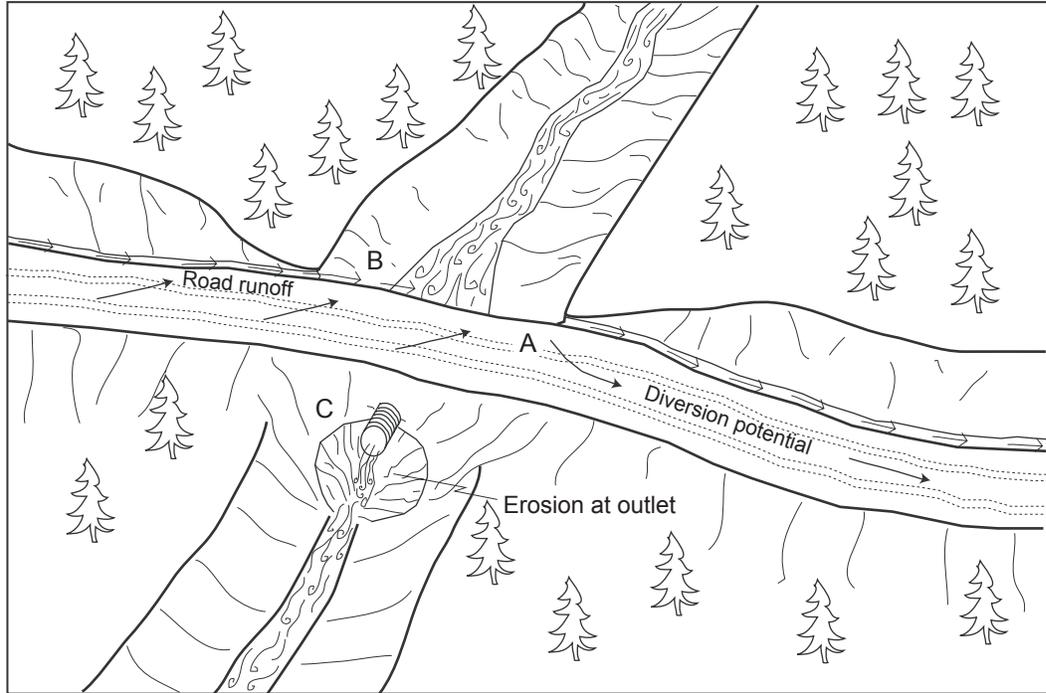
Problem condition (before)

- A - Diversion potential
- B - Road surface and ditch drain to stream
- C - Undersized culvert high in fill with outlet erosion

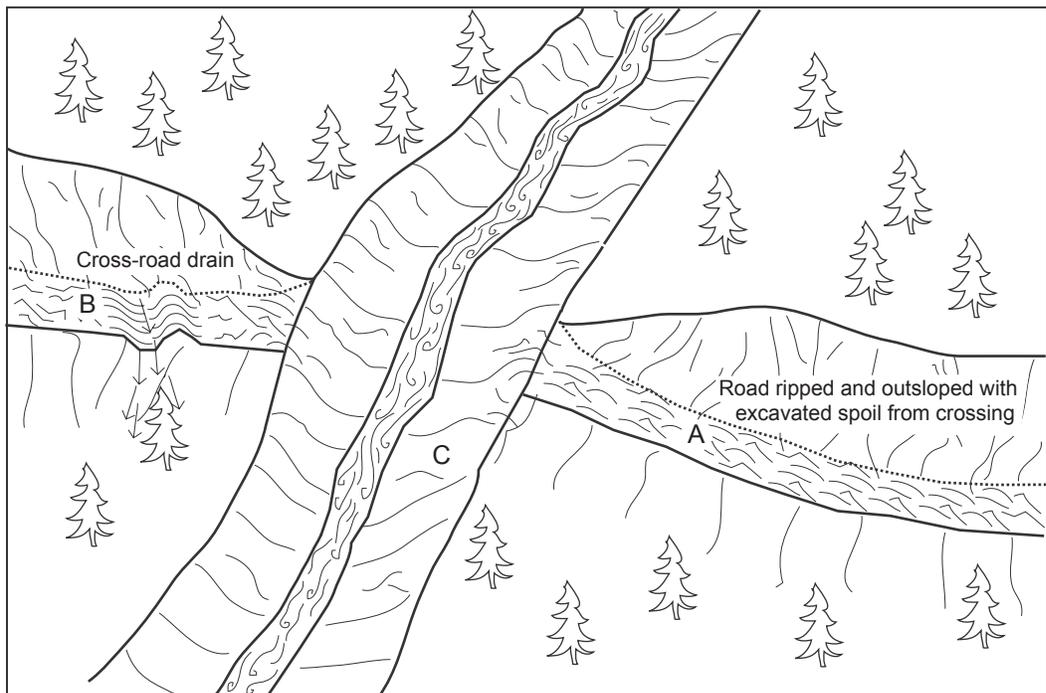
Treatment standards (after)

- A - Diversion prevented by road surface ripping and outsloping using excavated spoils
- B - Road surface and ditch disconnected from stream by road surface decompaction and cross-road drains
- C - Stream crossing fill completely excavated

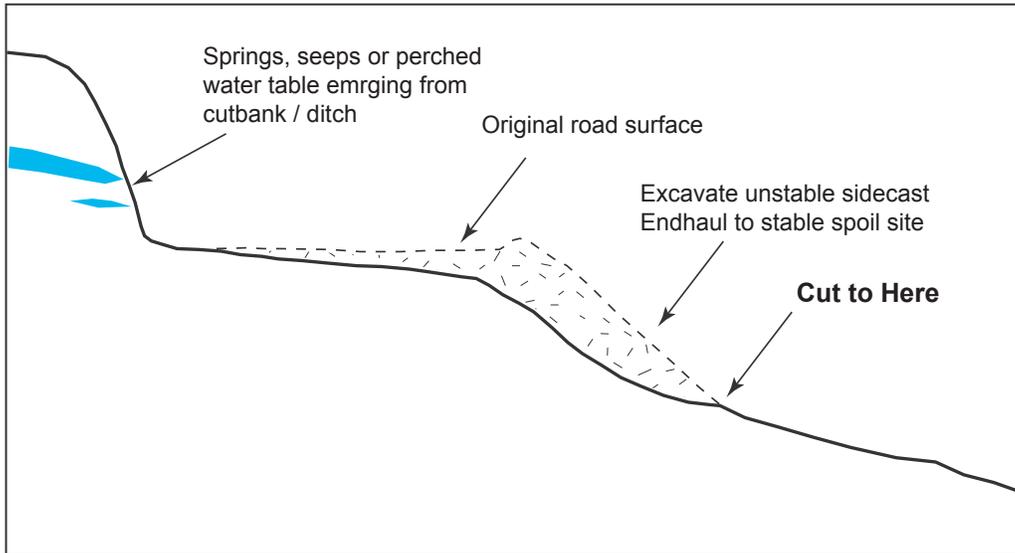
Export outslope (EPOS)

Typical Design for Road Decommissioning Treatments Employing Export and In-Place Outsloping Techniques

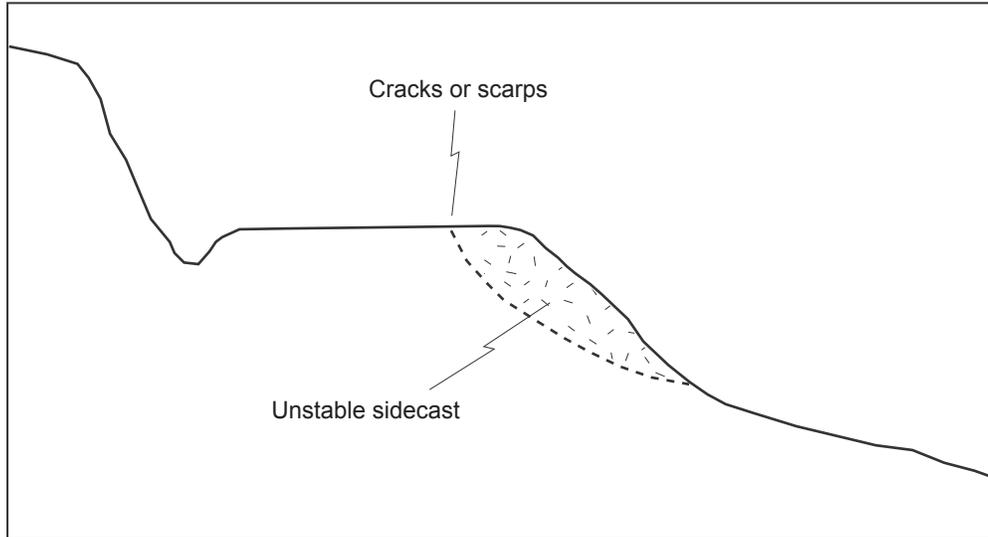
Before

Typical Excavation of Unstable Fillslope on a Decommissioned Road
